Service Bulletin

Bulletin No.: 22-NA-080

Subject: Diagnostic Tips for Engine Related Shudder Concerns

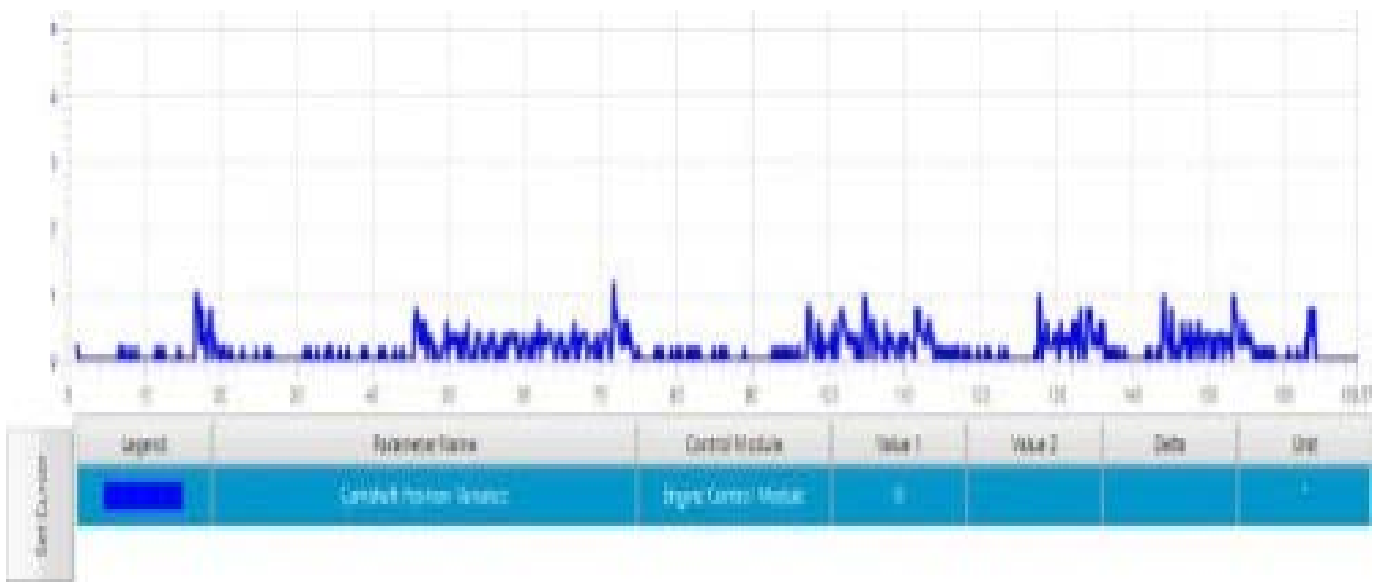
Normal operation (variance under 4 degrees)

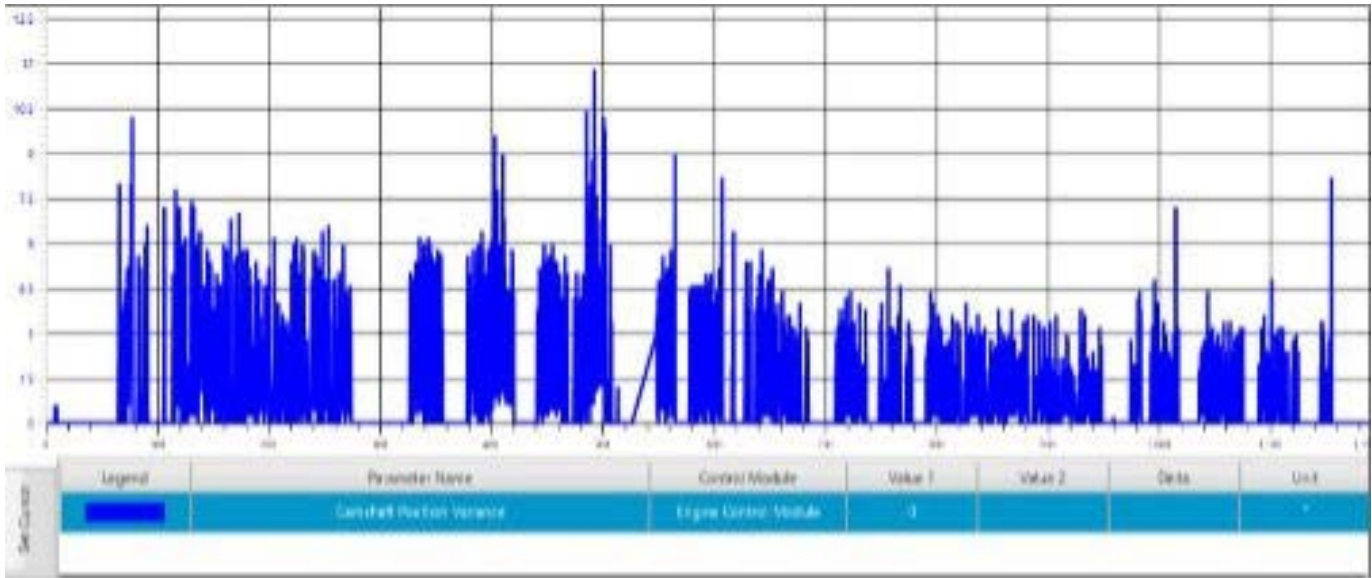
6029096

| Cause | This condition may be caused by the camshaft actuator magnet sticking. |

Suspect fault in camshaft actuator system (variance over 4 degrees)

| Correction | If the concern has been determined to be engine related and not being caused by the transmission the following diagnosis may be helpful: – While duplicating the Shudder or Surge concern monitor the data parameter "Camshaft Position Variance" in GDS2. Although target variance is 0 degrees, it is not uncommon to observe variance of up to 3-4 degrees on a properly functioning system. – Any variance exceeding 3-4 degrees could potentially cause a noticeable Shudder or Surge concern. If after diagnosis you confirm that the concern has been isolated to the camshaft actuator system, it is recommended to replace the camshaft actuator magnet and re-evaluate. Refer to <i>Camshaft Position Actuator Magnet Replacement in SI</i> . If the Shudder/Surge is still present after camshaft actuator magnet replacement and camshaft actuator variance is over 4 degrees, refer to GM Service Information for further diagnosis. |
