Service Bulletin

Bulletin No.: 22-NA-144

Subject: Power Windows, Door Locks and Outside Mirrors Inoperative, Unwanted Theft Alarm Activation, Random Messages Displayed on the Drivers Information Center (DIC)

Brand:	Model:	Model Year:		VIN Breakpoint:		Engine:	Transmission:
		from	to	from	to		
GMC	HUMMER EV	2022	2022	1GT40FDA1NU100230	EOP

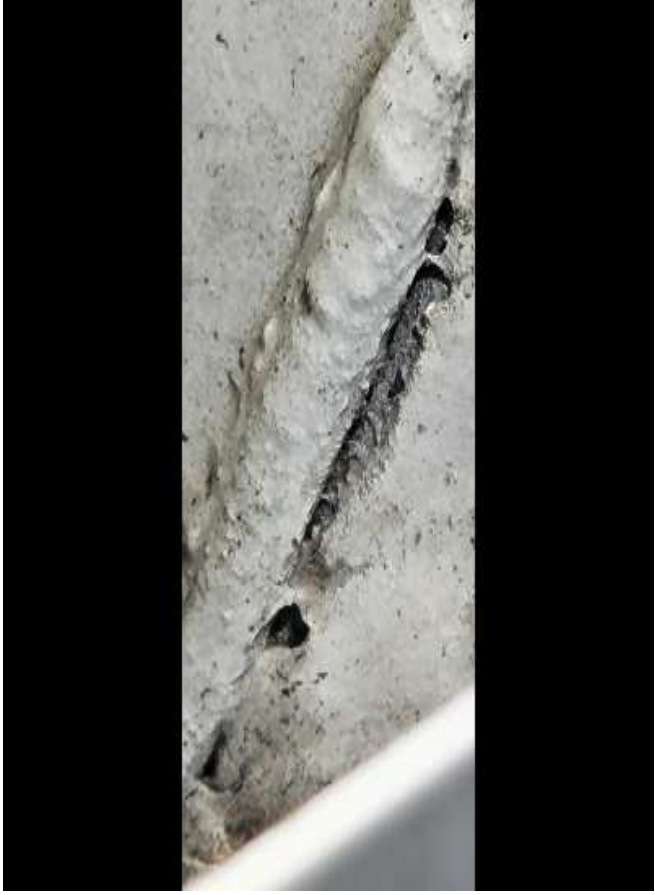
<p style="text-align: right;">6103692</p> <p>Note: The image above depicts a close-up of a failed seal below the drivers side windshield area.</p> <p>This condition may be caused by The Driver's Front Door X500 in-line connector may have corroded terminals due to a water leak entering inside the upper A-Pillar through the panels not sealed properly.</p>
<p>Correction</p>	<p>Open the x500 and inspect for corroded terminals. Perform water leak test on suspected sheet metal area, reseal, re-test for leaks.</p> <p>Repair and or replace X500 terminals as required.</p>

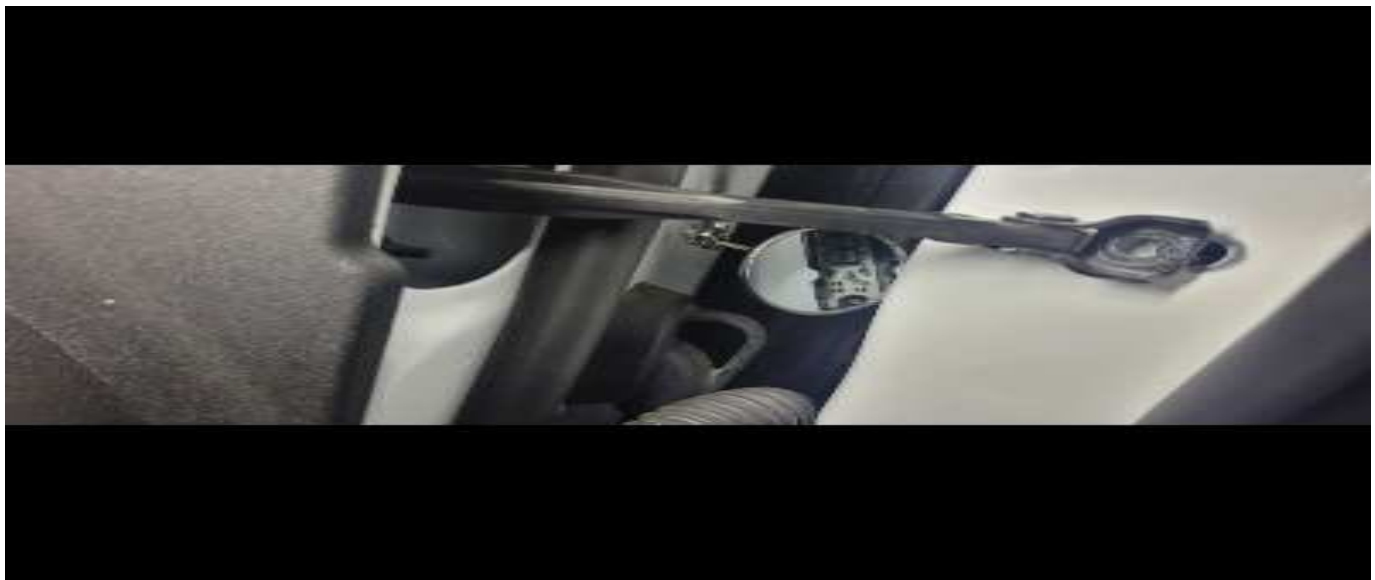
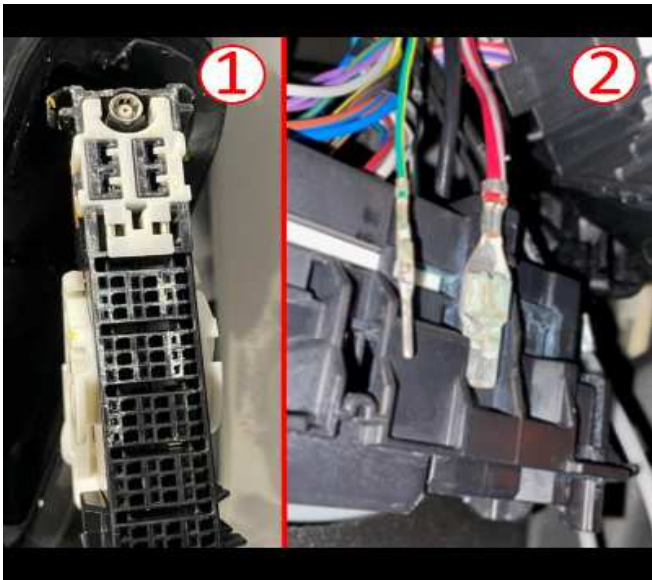
Note: The graphics above is an example of what the corrosion may look like in the X500 connectors

- If corrosion is found at the door side connector (1) or the instrument side connector (2), continue to step 7.
- If corrosion is not found on the connectors, refer to step 14.
