Service Bulletin

Bulletin No.: 18-NA-268

Subject: Rattle Noise Heard and/or Vibration from Front of Vehicle When Engine is Running at Slower Speeds

Brand:	Model:	Model Year:		VIN:		Engine:	Transmission:
		from	to	from	to		
Chevrolet	Corvette	2014	2019	—	—	6.2L (LT1, LT4)	6L80, 8L90 (MYC, M5U)

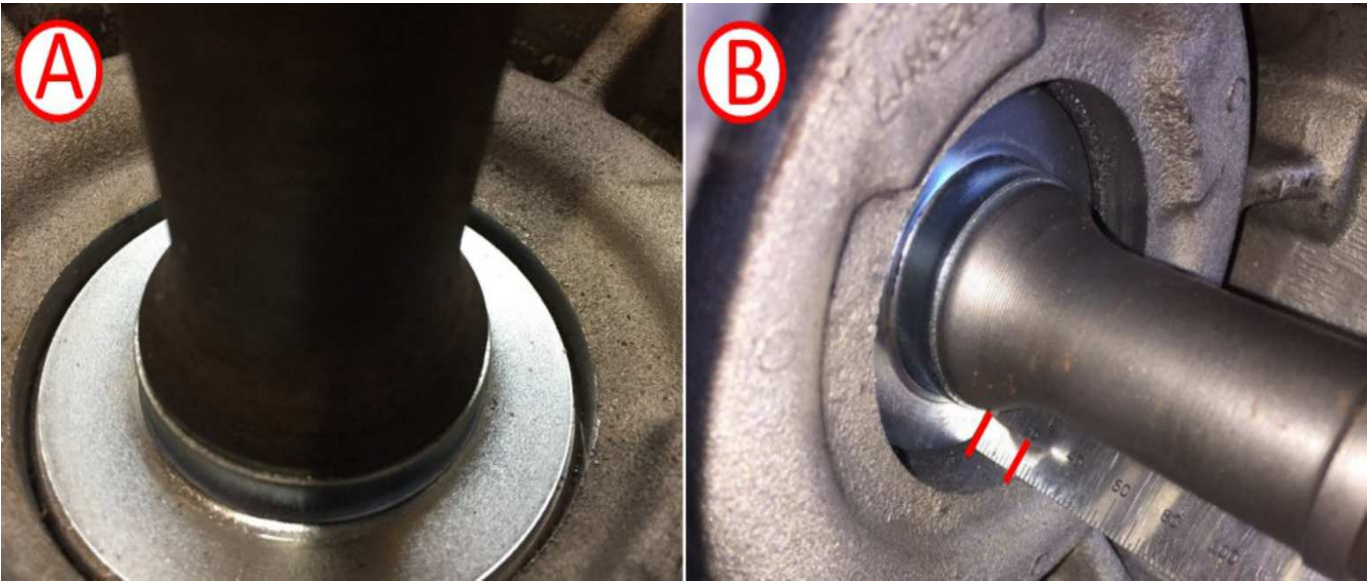
5315085

3. Inspect that the front bearing/slinger is flush (A) with the housing:
 - ⇒ If the bearing/slinger has been validated to be the cause of the noise and/or found to be pushed rearward more than $\frac{1}{4}$ inch (6 mm) (B), continue with *Propeller Shaft Replacement* in the Service Manual.

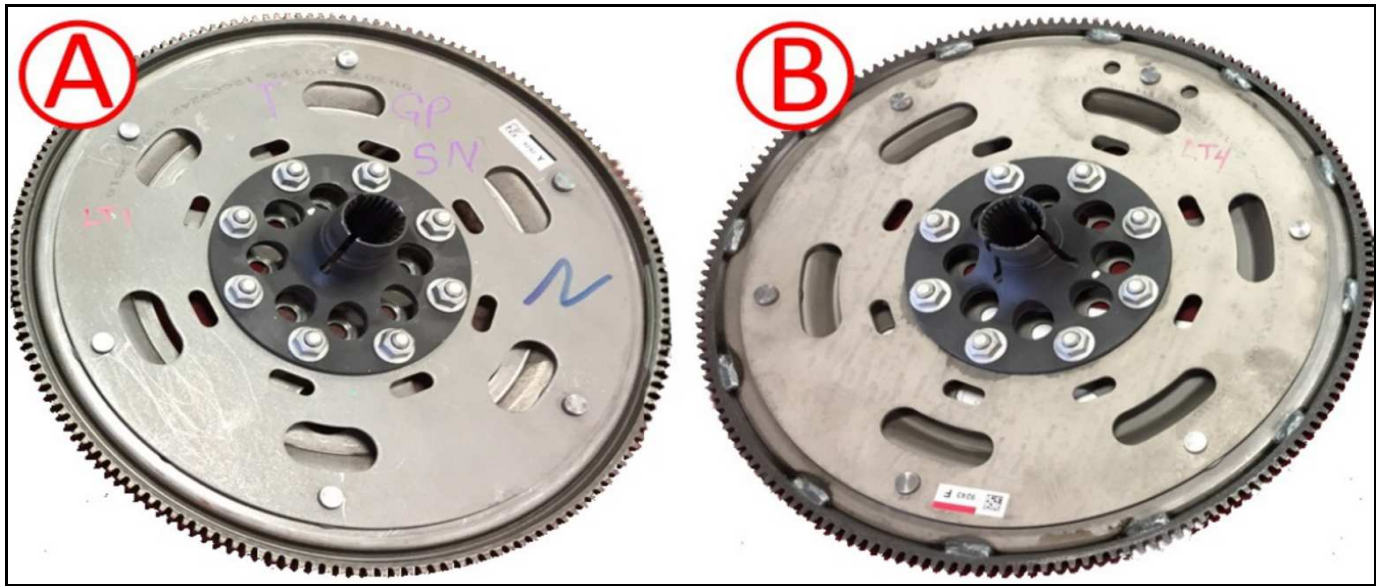
5300907

4. Verify that the propshaft hub clamp bolt is properly torqued.
 5. Inspect the flex plate:
 - If an LT1 flex plate is installed (A), it is crucial that the LT4 flex plate (B) be installed.
- ⇒ If the bearing/slinger is found to be pushed rearward more than ¼ inch (6 mm), continue with *Propeller Shaft Replacement* in the Service Manual.
- If the LT4 flex plate is installed, but the bearing/slinger is pushed rearward, continue to the next step.

Note: Add medium strength thread locker to the DSA flex plate clamp pinch bolt.
