LTB01304NAS2

TECHNICAL BULLETIN

Outer Tail Lamps Water Ingress/Cracking lenses/Noise When Driving

MODEL:	MODEL YEAR:	VIN:	ASSEMBLY PLANT:
New Range Rover Evoque (LZ)	2020-2023	000268-185064	Halewood

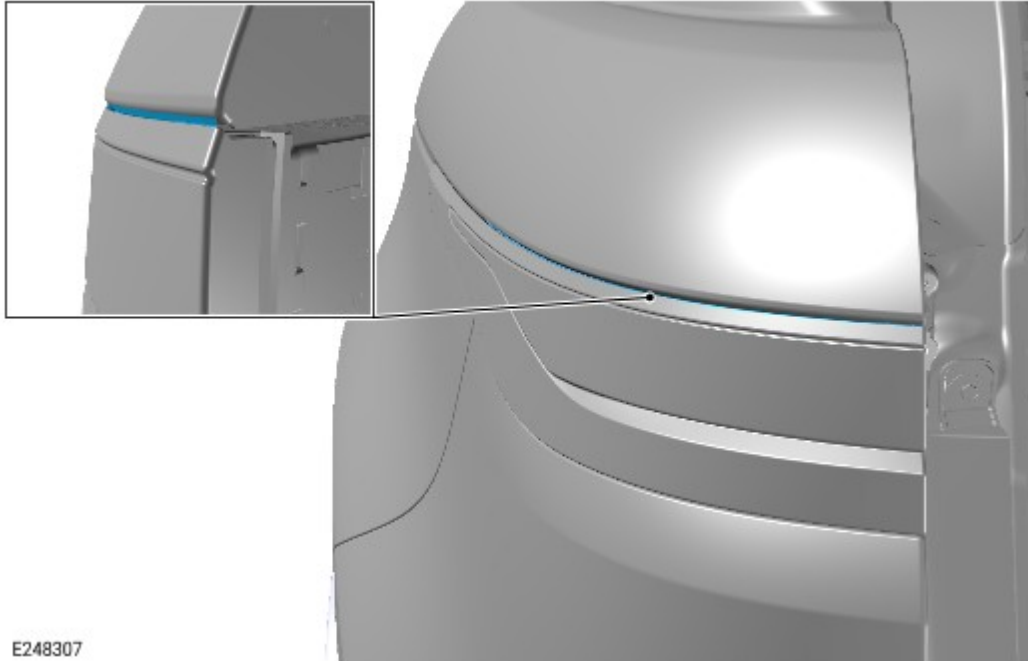
E248307

Inspect the outer tail lamp and rear quarter panel gap on both sides of the vehicle.

- If **either** of the outer tail lamp and rear quarter panel gaps are less than 1 mm, continue to 'Outer Tail Lamp Alignment'.
- If **neither** of the outer tail lamp and rear quarter panel gaps are less than 1 mm, this is not the cause of the customer's concern.

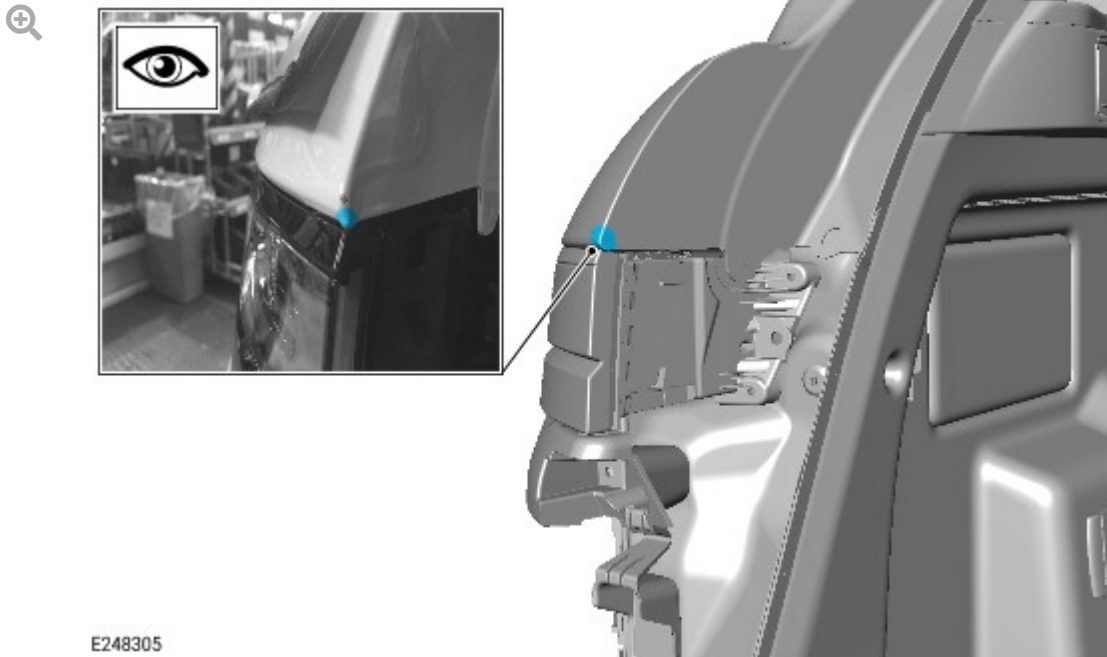
E248305

Visually inspect the area of the rear quarter panel shown.

- If there **is** excessive paint in the area shown or the outer tail lamp has cosmetic cracks and / or water ingress, continue to step 5.
- If there **is not** excessive paint in the area shown and the outer tail lamp does not have cosmetic cracks and / or water ingress, continue to step 8.
