Service Bulletin

Subject: Malfunction Indicator Lamp (MIL) Illuminated – Multiple Transmission DTCs Set

| Page 2 | August, 2022 | Bulletin No.: 21-NA-033 |

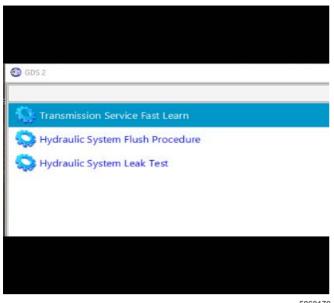
9. Select the Hydraulic System Flush Procedure.

Note: Performing the Hydraulic System Flush Procedure test may take approximately 8 minutes to perform in its entirety. Disregard the current statement below stating 30 seconds to complete.
