Service Bulletin

Bulletin No.: 21-NA-215

Subject: Pop Noise Heard on Heavy Acceleration Only, Lack of Power When on the Highway, Stall- Multiple DTC's or No DTC's Set

Brand:	Model:	Model Year:		VIN Breakpoint:		Engine:	Transmission:
		from	to	from	to		
Buick	Encore GX	2021	2022	SOP	KL4MMBS20NB085427	LIH, L3T	
Chevrolet	Trailblazer (VIN M)				KL79MUSL5NB082536

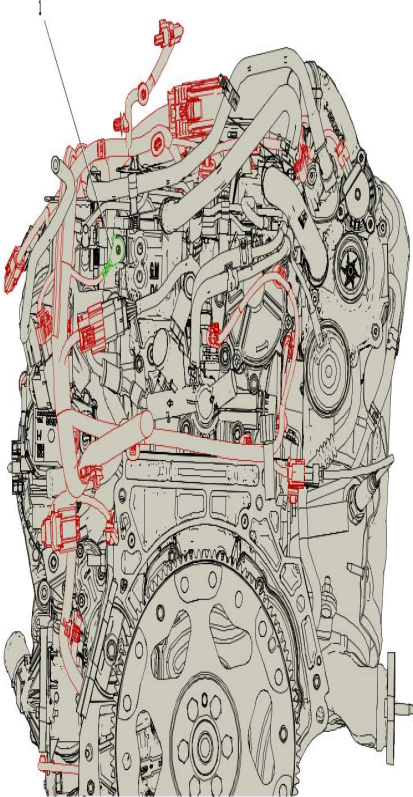
G106 LIH ground wire location

<p style="text-align: right;">5925499</p> <p>G106 L3T ground wire location This condition may be caused by a loose ground located at G106 (1). – The G106 ground nut may not have been tightened to specifications from the factory.</p>
<p>Correction</p>	<p>Locate the G106 ground. Inspect the stud and replace if needed, then tighten nut.</p>
