Service Bulletin

Bulletin No.: 22-NA-145

Subject: Super Cruise Enhancement: Trailering and Active Lane Change

Brand:	Model:	Model Year:		VIN:		Engine:	Transmission:
		from	to	from	to		
GMC	HUMMER EV	2022	2022

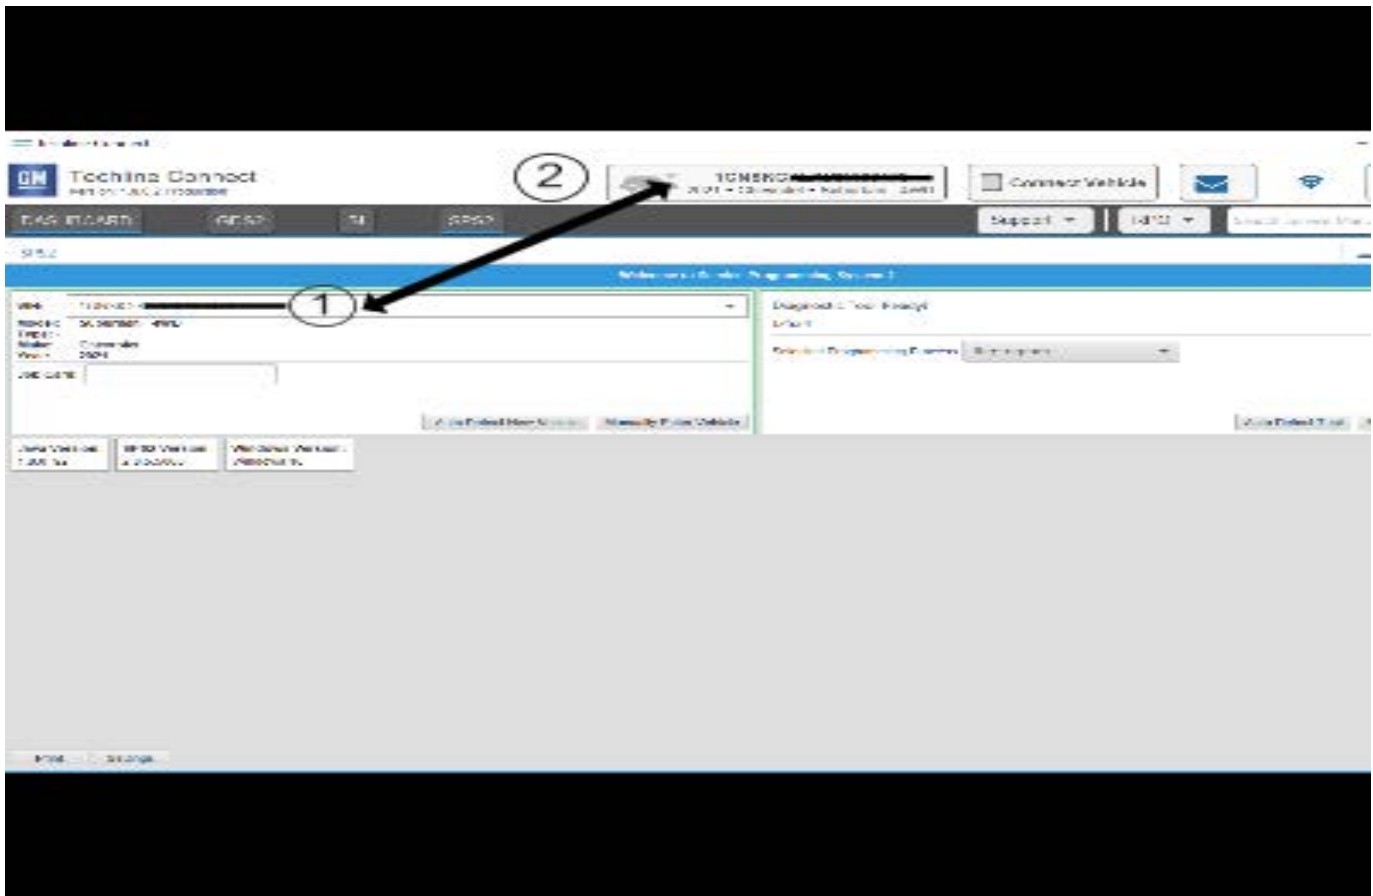
5743643

Caution: Be sure the VIN selected in the drop down menu (1) is the same as the vehicle connected (2) before beginning programming.
