Technical Service Bulletin

SUBJECT:		DRIVER'S SEAT GRADUALLY & UNINTENTIONALLY MOVES DOWN		No: TSB-22-52A-004
				DATE: July 2022
				MODEL: See Below
CIRCULATE TO:	<input type="checkbox"/> GENERAL MANAGER	<input checked="" type="checkbox"/> PARTS MANAGER	<input checked="" type="checkbox"/> TECHNICIAN	
<input checked="" type="checkbox"/> SERVICE ADVISOR	<input checked="" type="checkbox"/> SERVICE MANAGER	<input type="checkbox"/> WARRANTY PROCESSOR	<input checked="" type="checkbox"/> SALES MANAGER

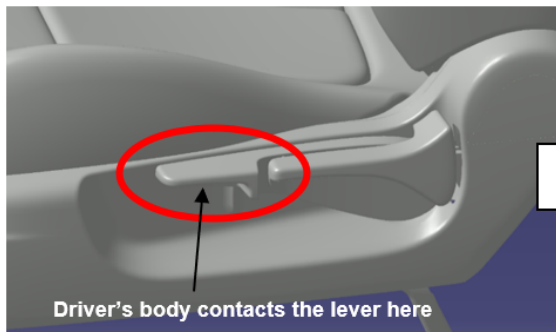
【Current shape】

The driver's seat gradually goes down without the manual height adjustment lever being intentionally operated. Contact is easily and unintentionally made with the height adjustment lever when the driver is entering and exiting the vehicle.

This TSB instructs dealers on how to replace the height adjuster lever with a new part on a customer complaint basis. The shape of the high adjuster lever has been changed to help prevent unintentional adjustment and downward seat movement.

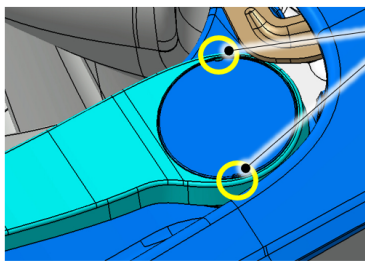
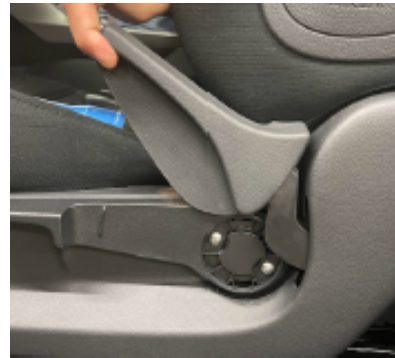
Groove around the cap of the height adjuster lever

2. To remove the height adjuster lever cap, insert tool into the groove surrounding the cap as illustrated.
