Model 520 HVAC Service Ports Spaced Incorrectly

Author: Darrell Cook

7/12/2022

Bulletin #01-085

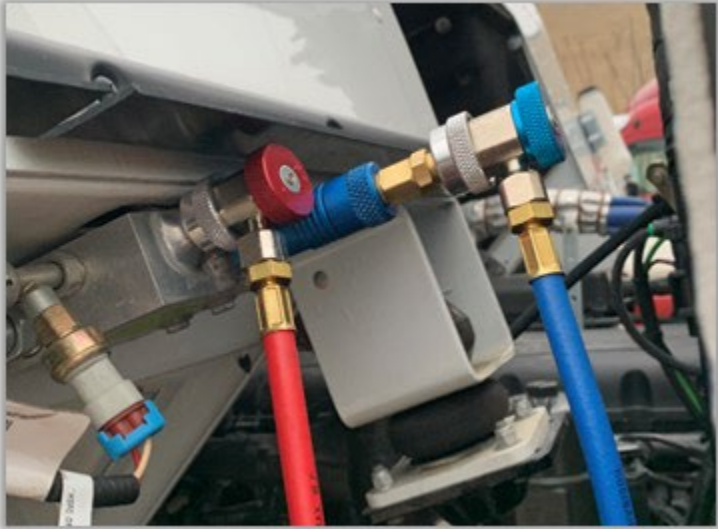
Title (metadata)	Bulletin #01-085: Model 520 HVAC Service Ports Spaced Incorrectly
Description	Model 520 HVAC Service Ports Spaced Incorrectly
Bulletin No.	Bulletin #01-085
Bulletin Category	Field Service
Supplier (Recall Only)	
Image	
Service Subject	Model 520 HVAC Service Ports Spaced Incorrectly
Section	HVAC - 01
What's New Abstract	Info Only – Certain 520 model chassis built between 2014 and 2021, and equipped with the Red Dot HVAC system, may have service port spacing which will not allow the connection of a pressure gauge to both the high and low side service ports simultaneously. A specific tool is available from the supplier that will allow a technician to bypass this design issue.
Revision	
Condition / Chief Complaint	HVAC service ports are spaced too closely together and prevent a technician from connecting a pressure gauge to both high and low side service ports at the same time.
Chassis Affected	520 model chassis with Red Dot HVAC system.

Service Action	<p>Information Only A tool is available for dealerships to purchase and use to bypass the current design.</p>									
Parts	<p>Parts are available from supplier "AirSept".</p>

<p>*Purchase either the High or Low side extender part listed above as either one will work to bypass the current design.</p>
