Check engine light illuminated, Fault P012800. M274 Hybrid

Topic number	LI20.10-P-074508
Version	1
Function group	20.10 - Coolant pump, coolant thermostat
Date	7/13/22
Validity	Models 205 and 253 plug-in hybrid
Reason for change

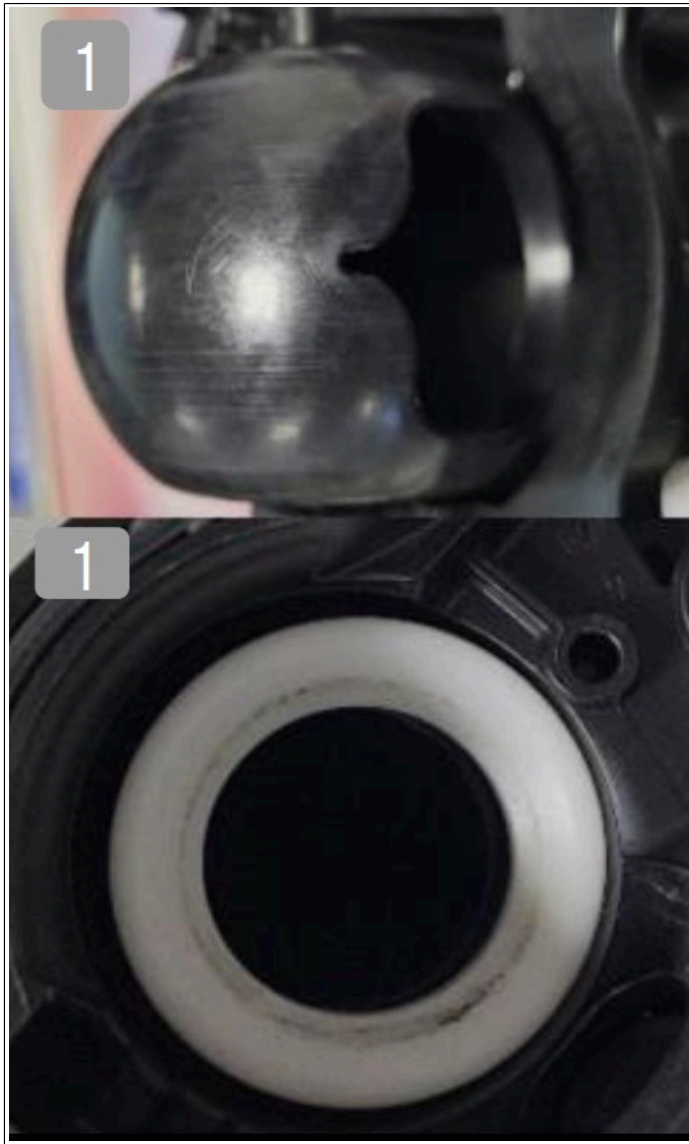
Attachments	
File	Description
Thermostat ball NOK.jpg

Fault code stored P012800-The coolant temperature is below the coolant thermostat specified temperature.

- 1- Update HVAC with latest software
 - 2- Perform guided test for fault P012800 and performed repairs per XENTRY diagnosis.
- If thermostat requires replacement flush cooling circuit in both directions with 150L of water.
