Bulletin #: 2219

Various Vehicles with 3G VTS - Engine Start Inhibited and Fault Code Present

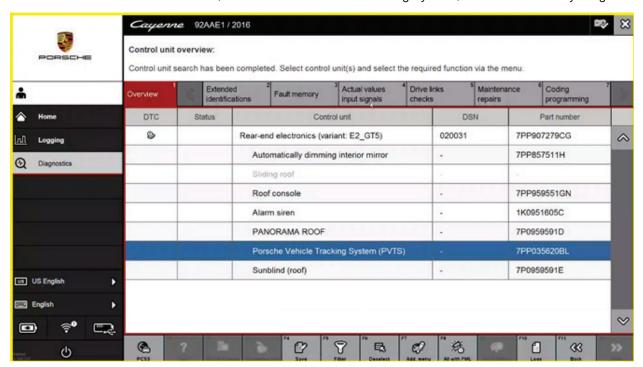
3. Confirm the VTS subscription is inactive.

- a. Using the PIWIS tester, select "Rear-end electronics" and click "Next (F12)."
- b. Under Rear-end electronics, select "Porsche Vehicle Tracking System," and unselect everything else.
