**Gears Cannot be Shifted or Pop Out Again When Changing Gear: Checking Installation Position of Shift Cable (65/22)**

Vehicle Type: **718 Cayman GT4 (982)/718 Spyder (982) 718 Cayman GTS 4.0 (982)/718 Boxster GTS 4.0 (982)/Boxster 25 year (982)**

Concerns: **Shift cable support bracket**

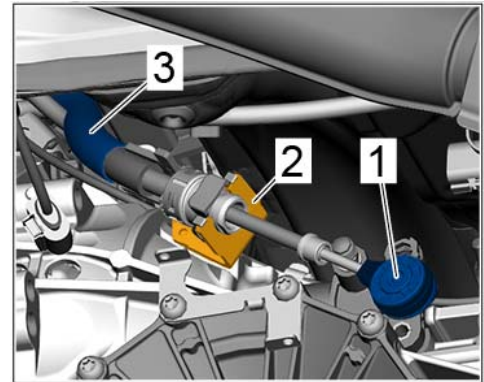
Shift cable

Work Procedure: 1 Check that ⇒ *Shift cable -3-* the shift cable is positioned correctly in the support bracket ⇒ *Shift cable -2-*.

- 1.1 If the shift cable is disengaged ⇒ *Shift cable -3-* from the support, continue with Replacing ⇒ *Technical Information '557819 support'*.
- 1.2 If the shift cable ⇒ *Shift cable -3-* is installed ⇒ *Shift cable -2-* correctly in the support, the cause of the fault must be analysed and corrected otherwise.
