DRW50 – 2023MY CX-50 – Incorrect Front Door Mechanical Key Shipped with Vehicle

A. Outline of Concern

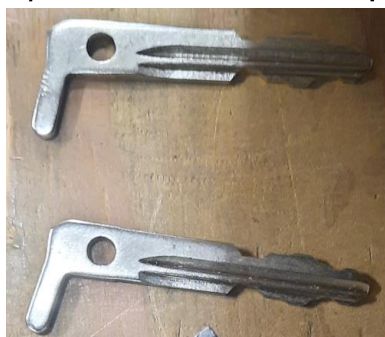
1. Remove the mechanical key from the key fob and try locking and unlocking the driver’s door with the key
 - a. If you can lock and unlock the door, STOP and enter a warranty claim for an inspection only.
 - b. If not successful contact Dealer Recall Help and advise the key did not work and you need part number P/N: VAY0-76-220. Then a SO# will be provided and the key and lock set will be shipped overnight to your dealer. Move to step 2 in the repair procedure.

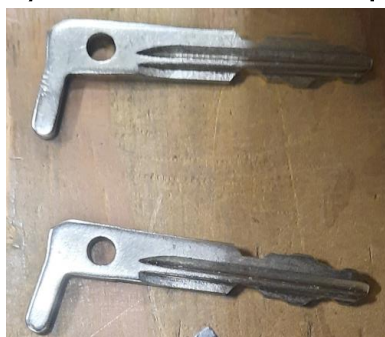
1. Remove the mechanical key from the key fob and try locking and unlocking the driver’s door with the key
 - a. If you can lock and unlock the door, STOP and enter a warranty claim for an inspection only.
 - b. If not successful contact Dealer Recall Help and advise the key did not work and you need part number P/N: VAY0-76-220. Then a SO# will be provided and the key and lock set will be shipped overnight to your dealer. Move to step 2 in the repair procedure.
