Subject: N222370180 - Service Update
Instrument Cluster Incorrect Calibration

Models: 2022 GMC Acadia

Service Update

N222370180 Instrument Cluster Incorrect Calibration

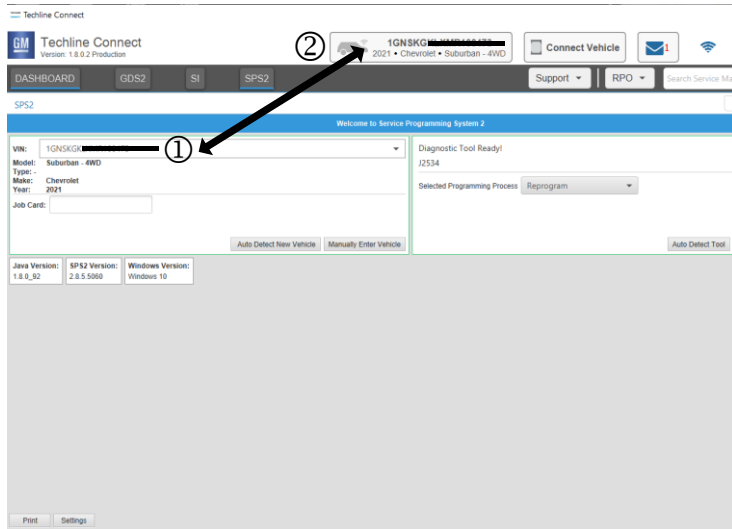
5743643

Caution: Be sure the VIN selected in the drop down menu (1) is the same as the vehicle connected (2) before beginning programming.

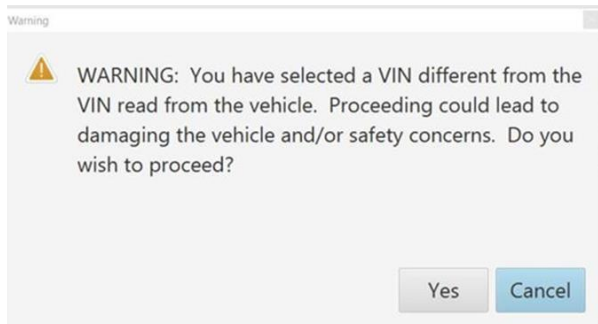
5877000

Important: If the vehicle VIN DOES NOT match, the message below will be shown.
