Seal on Mirror Attachment Point Wrinkled: Replacing Spacer Between Mirror Attachment Point and Door Seal (212/21)

Vehicle Type: **911 Turbo (992)/911 GT3 (992)**

Model Year: **As of 2021 up to 2022**

Concerns: **Door seal on mirror attachment point**

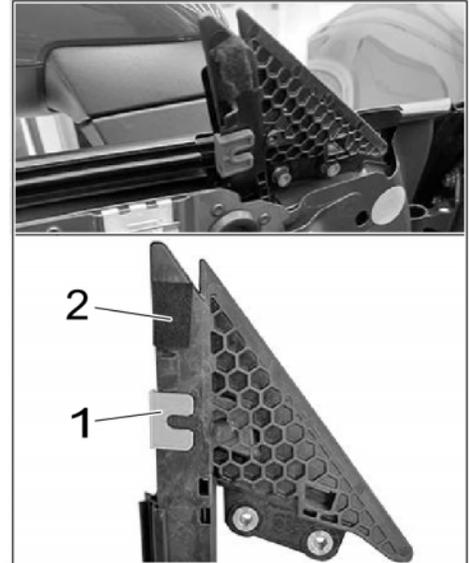
Position of spacer and felt strip

Information: Customers are complaining that the door seal on the mirror attachment point wrinkles. This is caused by the lightweight shims, which are thicker and sharper than the safety glass (ESG). As a result, the door seal will spring up when the lightweight shims close.
The fault type can occur on the driver's and/or passenger's side.

Work Procedure: 1 Install spacer ⇒ *Position of spacer and felt strip -1-* underneath the lug as shown in ⇒ *Position of spacer and felt strip* .
2 Affix felt strips ⇒ *Position of spacer and felt strip -2-* above the lug as shown in ⇒ *Position of spacer and felt strip* .
