Complaint - Over the Air (OTA) software update failed: Observe specified procedure (192/20)

Model Series: **Taycan (Y1A)**

Concerns: **All OTA (Over the Air) enabled control units**

Information: The Over the Air (OTA) software update failed and an error message appears in the central display of the Porsche Communication Management (PCM).

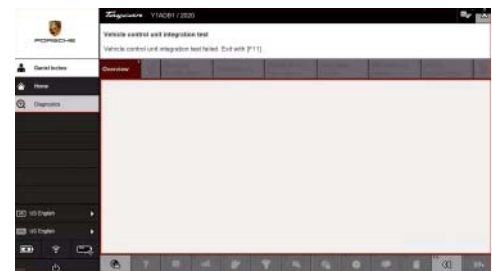
Vehicle control unit integration test failed

If the integration test fails, this is displayed as a result ⇒ *Vehicle control unit integration test failed.* Then complete the following steps:

- 7.1 In the Additional menu (F7), execute the "Maintenance of vehicle data with PIWIS ONLINE" function and write the current vehicle data record from the online system into the vehicle.
- 7.2 Carry out the integration test again.
- 7.3 In the event of a further fault, contact Technical Support.
