ANA5 – Reworking Wiring Harness for Front Seats (Stop Delivery/Recall Campaign)

Revision: This bulletin replaces bulletin Group 9 87/22 ANA5, dated July 15, 2022.

Model Line: **Taycan (Y1A)
Taycan Cross Turismo (Y1B)
Taycan Sport Turismo (Y1C)**

Concerns: **Wiring harness for front seats on vehicle side**

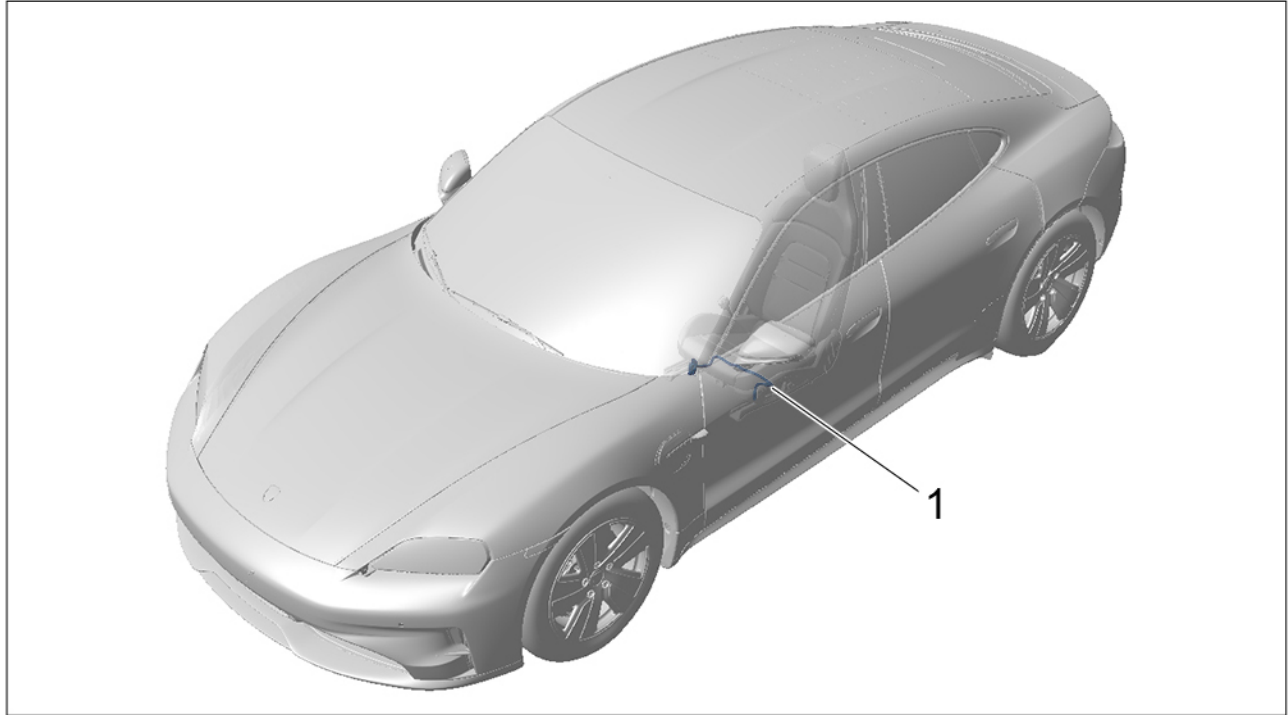
Installation position of wiring harness for front seat (shown on front left seat)

1 – Front seat wiring harness (reworking)

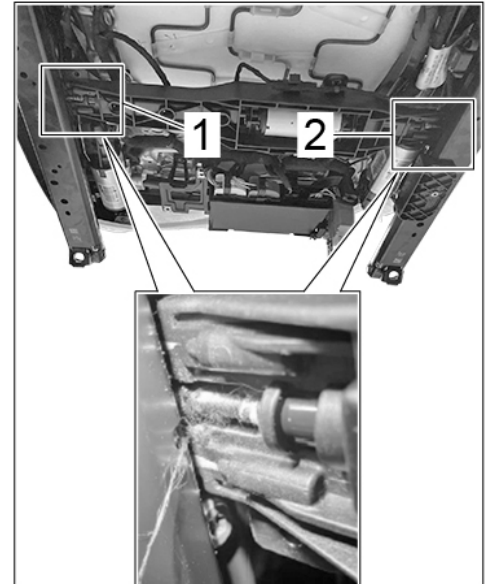
- Work Procedure: 1 Remove left and right front seats. ⇒ *Workshop Manual '720119 Remove and install front seat'*
- 2 Check drive spindle for seat fore-and-aft adjustment at the left ⇒ *Drive spindle for seat fore-and-aft adjustment -1-* and right ⇒ *Drive spindle for seat fore-and-aft adjustment -2-* on **both front seats** for trapped fibres from the protective tube for fabric.

Drive spindle for seat fore-and-aft adjustment

If the drive spindle is contaminated with fabric fibres, remove them using a suitable tool.
Then continue with: ⇒ *Technical Information '720119 Checking protective tube for fabric and wiring harness'*

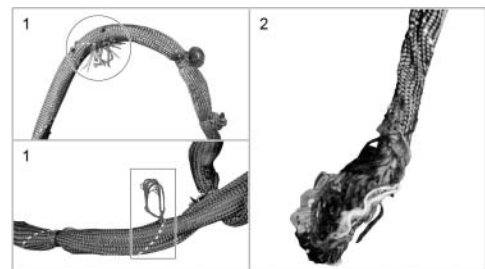
Work Procedure: 1 Check protective tube for fabric on the front seat wire harness for loose fibres ⇒ *Protective tube for fabric and front-seat wiring harness -1-* or damage ⇒ *Protective tube for fabric and front-seat wiring harness -2-*.

Protective tube for fabric and front-seat wiring harness

Assessment	Action
There are no loose fibres or damage visible on the protective tube for fabric.	Rework wiring harness, continue with section: ⇒ <i>Technical Information '720119 Reworking wire harness for front seats'</i>

<p>There are loose fibres visible on the protective tube for fabric and the electric wiring harness is not damaged.</p>	<p>Remove loose fibres and rework wiring harness. Continue with section: ⇒ <i>Technical Information '720119 Reworking wire harness for front seats'</i></p>
<p>There is damage visible on the protective tube for fabric and the electric wiring harness.</p>	<p>Repair electric line, remove loose fibres from the fabric protective tube and rework wiring harness. Continue with section: ⇒ <i>Technical Information '720119 Repair wire harness'</i></p>

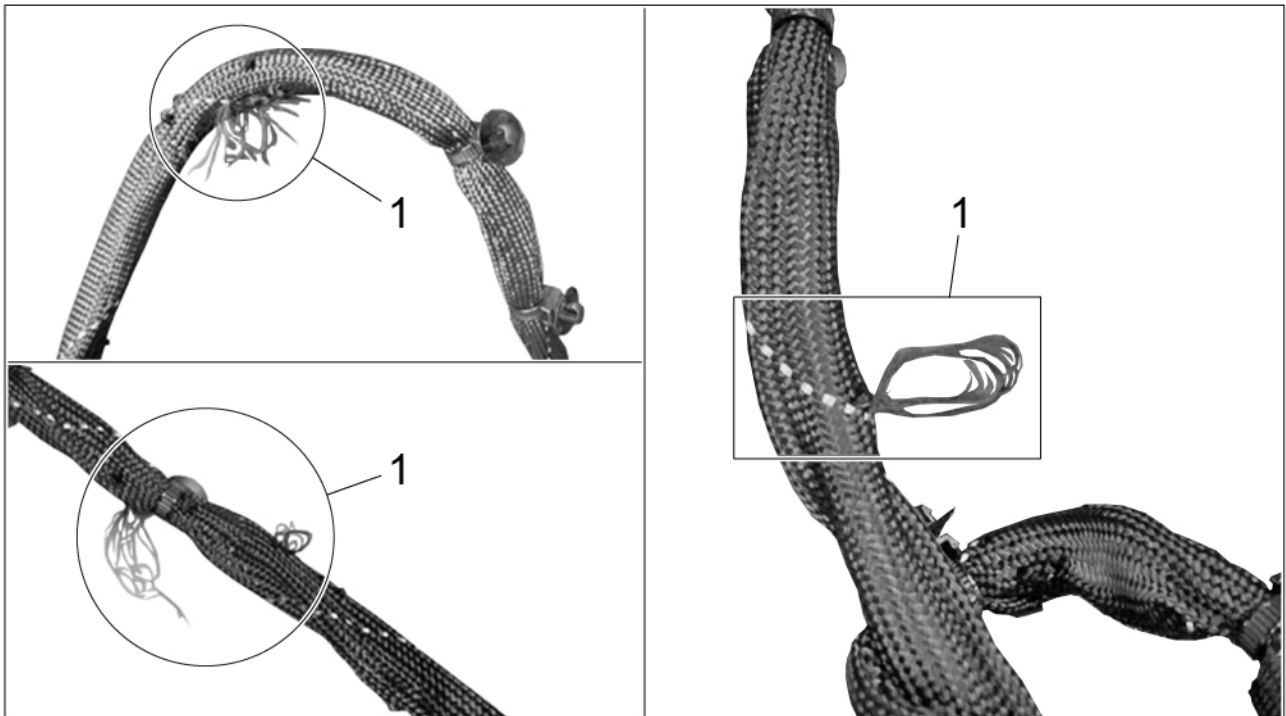
Loose fibres

Work Procedure: 1 If \Rightarrow *Loose fibres -1-* there are loose fibres on the protective tube for fabric, carefully remove these using a suitable tool.

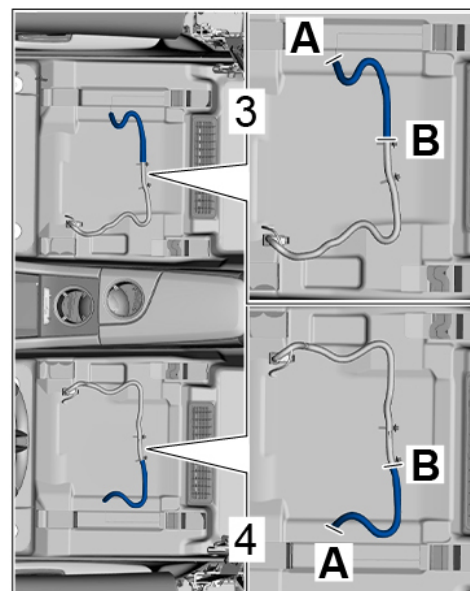
Reworking wire harness

- 2 Tightly wrap the wiring harness on the front right ⇒ *Reworking wire harness -3-* and left seat, ⇒ *Reworking wire harness -4-* including the protective tube for fabric, between the outlet opening on the carpeting ⇒ *Reworking wire harness -A-* and the first fastening clip on the seat frame ⇒ *Reworking wire harness -B-*. The textile fabric tape should overlap by approx. 1/3.
