Technical product information

Topic	Audible creak from the lower/central A Post when opening and/or closing the front door/s
Market area	Russische Föderation (5RU),Australia E04 Bentley rest Asia and Australia (6E04),China 796 VW Import Comp. Ltd (Vico), Beijing (6796),Germany E02 Bentley rest Europe (6E02),Japan E03 Bentley Japan (6E03),Korea, (South) E08 Bentley South Korea (6E08),United Arab Emirates E06 Bentley Middle East and Africa (6E06),United Kingdom E01 Bentley UK (6E01),United States E05 Bentley USA and rest America (6E05)
Brand	Bentley
Transaction No.	2064482/2
Level	EH
Status	Approval
Release date

Bentayga

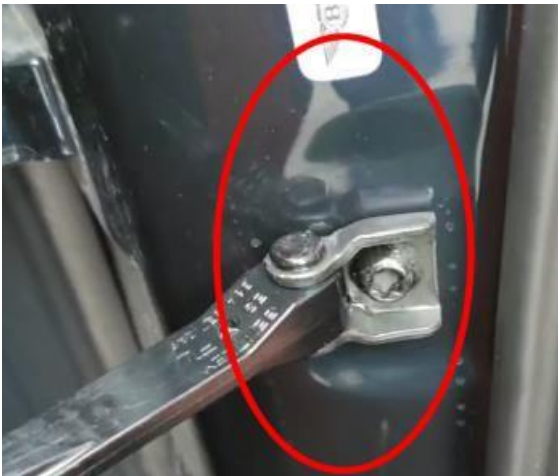
Figure 1

Audible creak coming from the lower/central A post in the vicinity of the check strap fixing point (Figure 1) during the opening and/or closing of the driver/passenger door

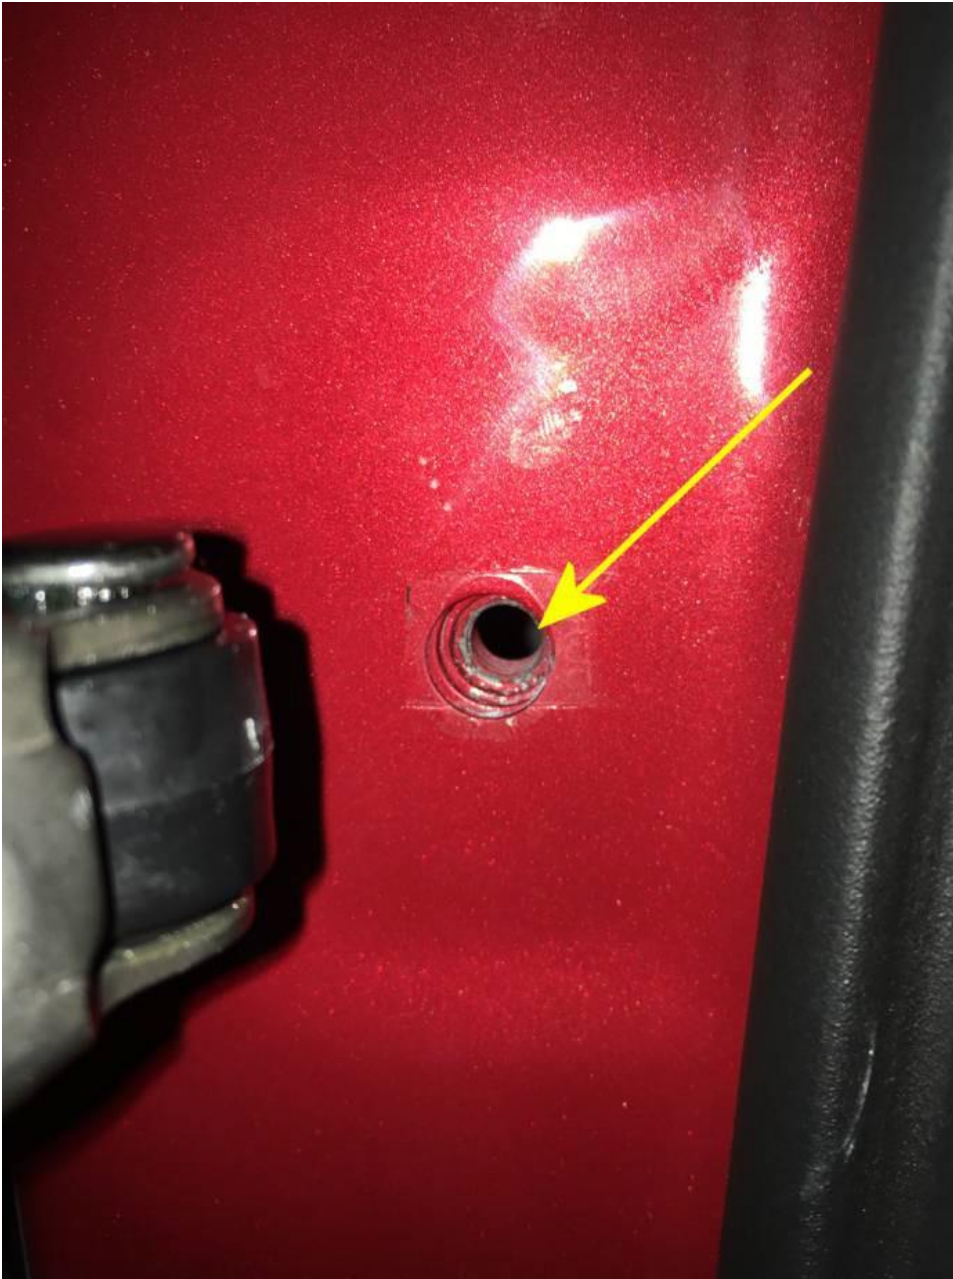
- 1) Referring to Rep.Gr 57 - Remove the door arrester fixing
- 2) The operative should now take a clear photograph of the position door arrester captive fixing
 - Figure 2 shows the captive fixing misaligned

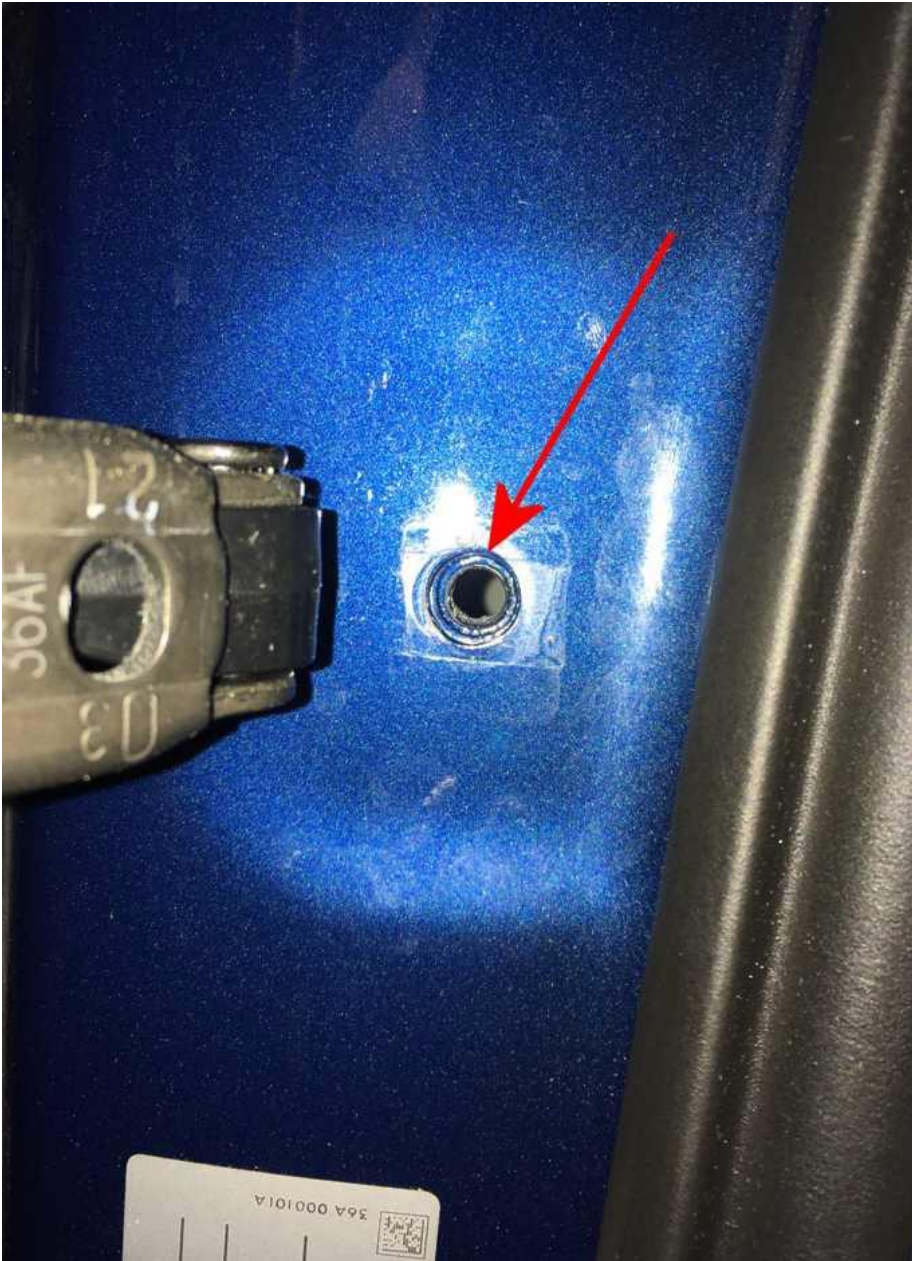
- Figure 3 shows the captive fixing aligned

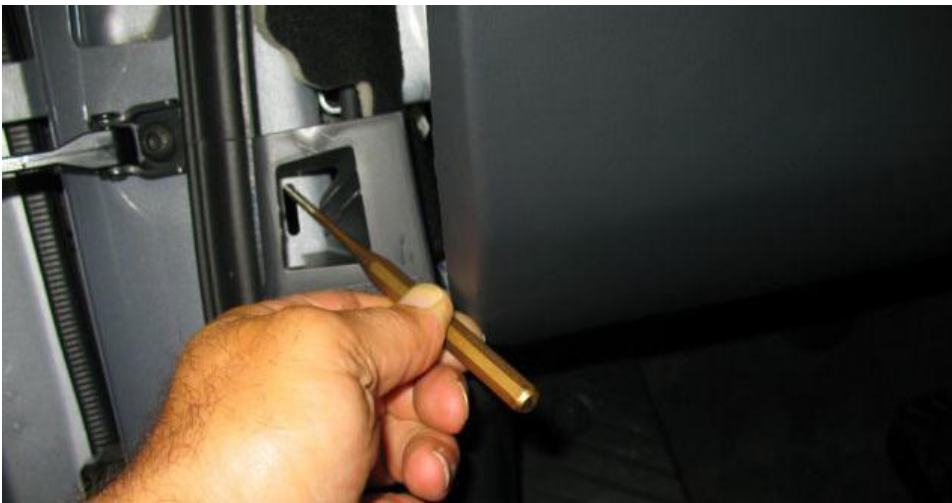
TIP: This creates enough space between the hinge reinforcement panel and the inner face of the A Post panel, the two panels can no longer rub against each other when opening and/or closing the door

5) Referring to Figure 6 - Place a suitable drift with a diameter of 4mm onto the hinge reinforcement panel as shown

- Using a suitable hammer in conjunction with the drift - Relocate the hinge reinforcement panel forward by 10 mm
