HYUNDAI Technical Service Bulletin	GROUP AUTOMATIC TRANSMISSION	NUMBER 22-AT-009H
	DATE JULY, 2022	MODEL ELANTRA N (CN7 N) KONA N (OS N) SANTA CRUZ (NXT) SANTA FE (TM) SONATA (DN8) VELOSTER N (JSN)
SUBJECT: 8-SPEED DUAL-CLUTCH TRANSMISSION ELECTRIC OIL PUMP (EOP) DTC

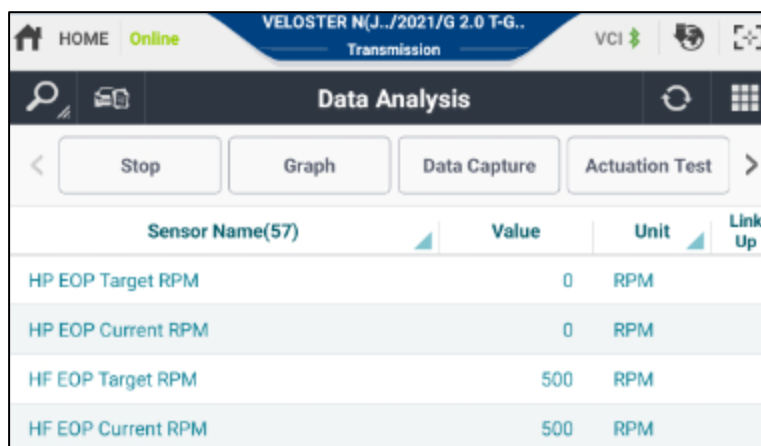
1. Attach a GDS and select **DTC Analysis** and **A/T** menu. Record the DTC and description. Delete the DTC.
2. From the GDS home screen, select **Data Analysis** and **A/T** menu and the sensors shown below. If the sensors show:
 - Continuous and changing output while driving, the wiring **currently** has no open/short circuits. Go to Step 4.
 - No continuous and changing output, the EOP or harness may have a fault. Go to Step 3.

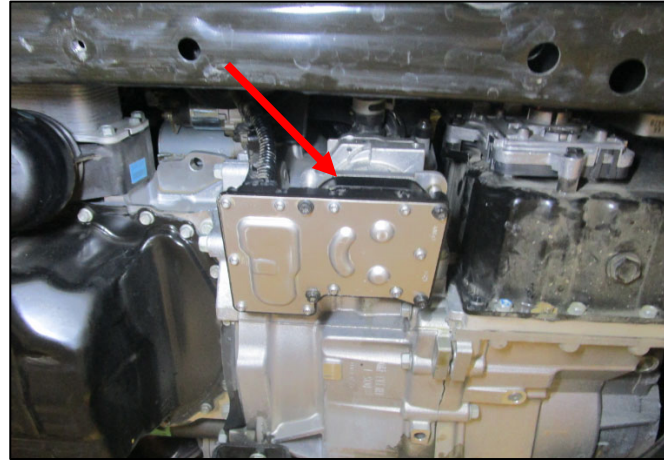
5. Record the preset radio stations.
Disconnect the negative battery terminal.
Remove the air cleaner
6. Raise the vehicle on a hoist.
Locate the HF EOP on the lower left side of
the DCT facing the radiator.
