Y1A Taycan

On Board Charger (OBC) Fault P31D200 "Charging Socket – Overtemperature"

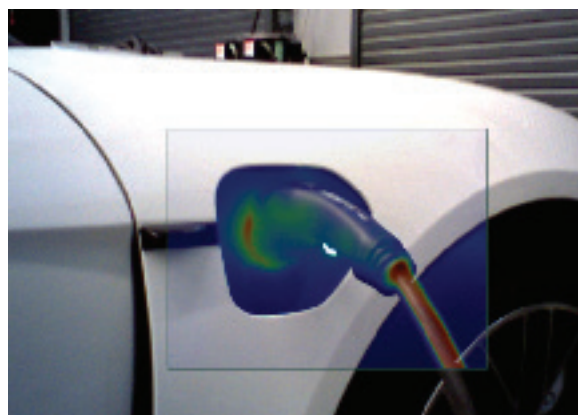
Figure 2

Measure temperatures around the vehicle cable after at least 1 hour of full-power AC charging (208-240V, 40A setting). Check the temperature of the cable sheath below the vehicle connector, at the vehicle cable handle, and at the charge port of the vehicle. Compare the measured temperatures to another known-good charging cable used in similar conditions and with similar settings.

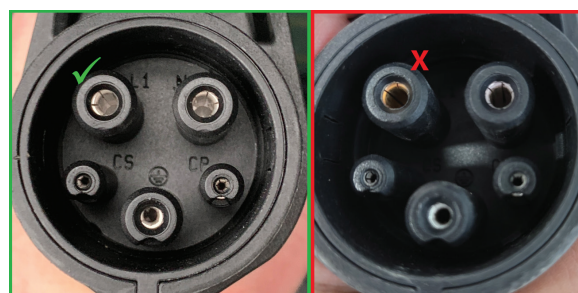
Figure 3

Visually inspect the pins in the vehicle cable connector for signs of overheating, paying particular attention to the L1 Pin. A vehicle cable and L1 Pin which was significantly or repeatedly overheated will show signs of discoloration (refer to Figure 3).

**Please advise customers to reduce charging current to maximum 30A (Mobile Charger Connect) or 50% (Mobile Charger Plus).**
