<b>HYUNDAI</b> <b>Technical Service Bulletin</b>	GROUP <b>CAMPAIGN</b>	NUMBER <b>22-01-052H</b>
	DATE <b>JUNE, 2022</b>	MODEL(S) <b>NEXO (FE)</b>
<b>SUBJECT:</b> INSTRUMENT CLUSTER SOFTWARE UPDATE (SERVICE CAMPAIGN T8M)

**Applicable Vehicles: Certain 2022MY Nexo (FE)**

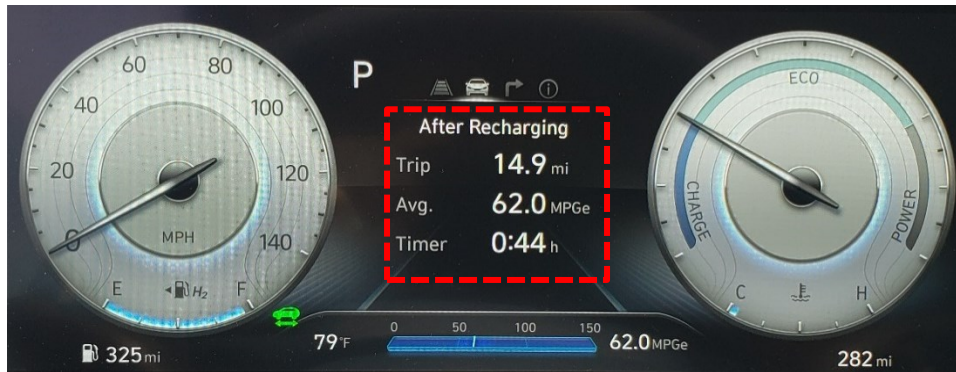
**Description:** Some 2022 Nexo (FE) vehicles may display the incorrect driving information (Trip, Avg., Timer) value in the "After Recharging" screen of the instrument cluster.

This bulletin provides the service procedure to update the instrument cluster software to resolve the condition stated above.
