# Technical Service Bulletin

GROUP <b>Campaign</b>	NUMBER <b>22-01-056H</b>
DATE <b>JULY 2022</b>	MODEL(S) <b>Venue (QX)</b>

**SUBJECT:** ECU UPDATE-QX G4 FIII 1.6 MPI ECU LOGIC IMPROVEMENT  
(SERVICE CAMPAIGN T8K)

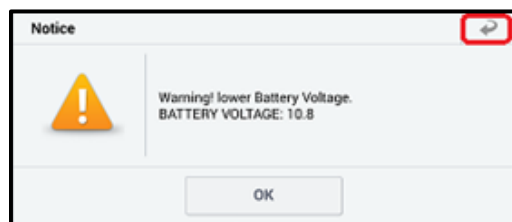
### GDS Vehicle Battery Voltage Warning:

If voltage is below 12 volts as per the GDS warning, then select **Back** and run the engine at least 15 minutes to reach an adequate battery state of charge to prevent ECU Update failure. Cycle the ignition **OFF/ON** before retrying ECU update again.
