# RCA-78-22-010-1: Adjust and Repair Cowl Harness

<b>Document Type</b>	Customer Satisfaction Campaign Bulletin
<b>Date</b>	July 22, 2022
<b>Affected Region(s)</b>	USA
<b>Affected Model(s)</b>	R1T
<b>Model Year(s)</b>	2022
<b>Approximate Build Dates</b>	August 2021 - March 2022

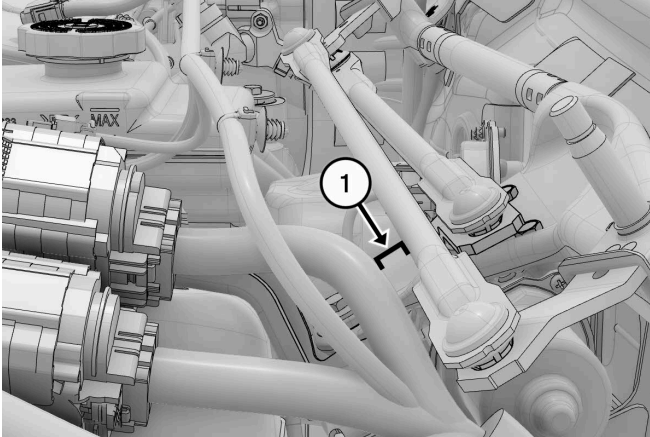
1. Remove: Screen, Leaf (refer to service manual procedure 647920010).
2. Check the minimum distance between the wiper linkage and the harness.

1	At least 40 mm (1 9/16 inches)
---	--------------------------------

- If the gap is 40 mm (1 9/16 inches) or greater, no additional work is required. Reinstall all components that were removed for access and replace all non-reusable components.
- If the gap is less than 40 mm (1 9/16 inches), continue to the next step.

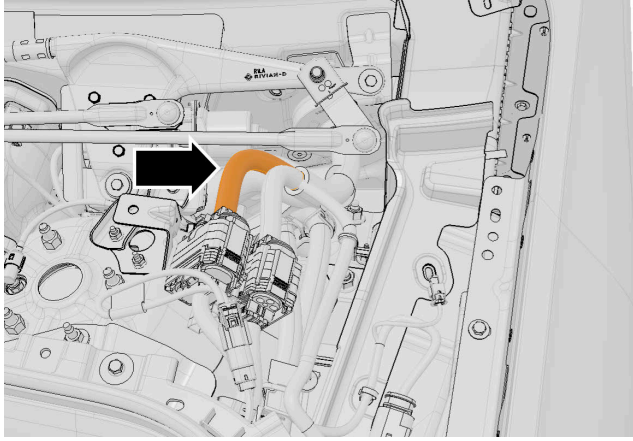
3. Inspect the wires in the highlighted area:

- If abrasion has damaged the wiring insulation:
  - If any of the following wires are affected, replace the harness. Escalate for diagnostic assistance. Make sure that the grommet is positioned correctly, as described in the [Reposition Grommet](#) section and that the harness is properly secured to the bracket, as described in the [Secure Harnesses to Bracket](#) section.

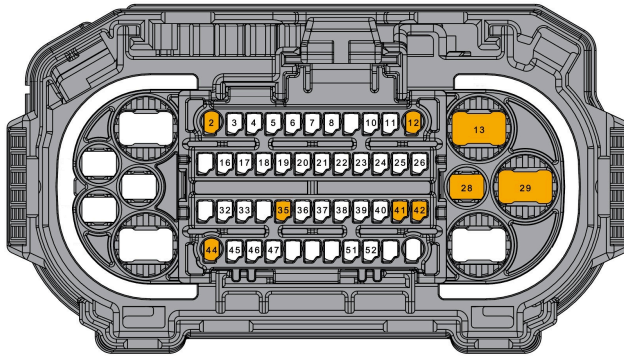
Pin	Color
2	Red/Orange
12	Red/Yellow
13	Brown
28	Black
29	Brown/Blue
35	White/Orange
41	Green/Yellow
42	Red/Yellow
44	Black

- Repair any other damaged wires. Escalate for diagnostic assistance. Continue to the [Reposition Grommet](#) section.
- If the protective tape has abraded and exposed wiring insulation, but the wiring insulation is not damaged, rewrap the affected area with new protective tape. Continue to the [Reposition Grommet](#) section.
- If the wiring and tape are undamaged, continue to the [Reposition Grommet](#) section.

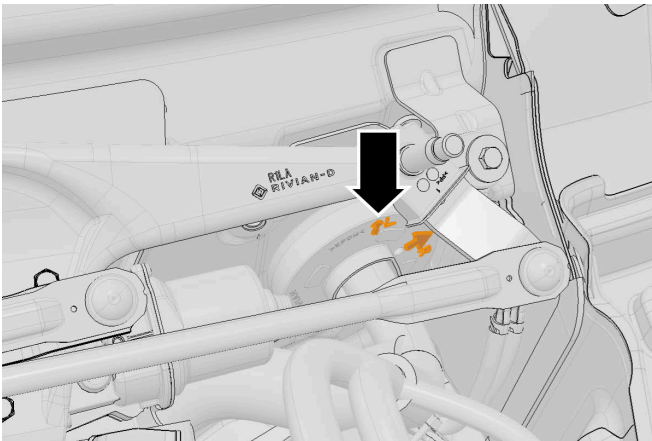
2. Inspect the position of the grommet:

- If the small arrow next to the "L" points upward, skip to the [Secure Harnesses to Bracket](#) section.
- If the small arrow next to the "L" points in a different direction, continue to the next step.

3. Rotate the grommet so that the small arrow next to the "L" points upward.
