Technical product information

Topic	HVAC not working – No air flow - DTC B10AE31 High Pressure sensor - No signal DTC logged within address 08
Market area	Russische Föderation (5RU),Australia E04 Bentley rest Asia and Australia (6E04),China 796 VW Import Comp. Ltd (Vico), Beijing (6796),Germany E02 Bentley rest Europe (6E02),Japan E03 Bentley Japan (6E03),Korea, (South) E08 Bentley South Korea (6E08),United Arab Emirates E06 Bentley Middle East and Africa (6E06),United Kingdom E01 Bentley UK (6E01),United States E05 Bentley USA and rest America (6E05)
Brand	Bentley
Transaction No.	2067429/2
Level	EH
Status	Approval
Release date

Bentayga W12 and V8 engine derivatives only

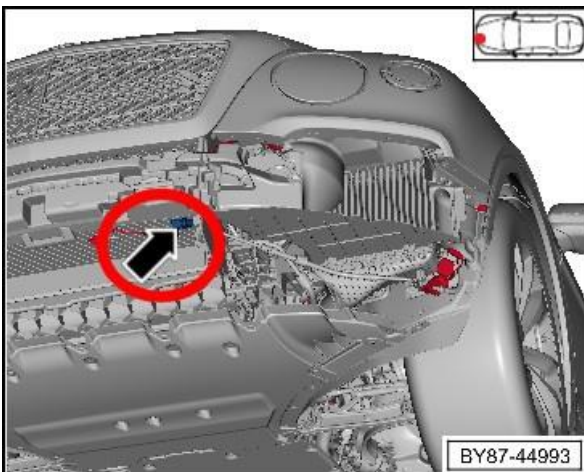
Figure 1

- HVAC not working to specification (No air flow)
- DTC B10AE31 High Pressure sensor - No signal DTC logged within address 08

- Gain access to High pressure sensor G65 (Figure 1)

- Replace G65 and associated parts (See parts information section)
 - Refit all previously removed components
 - Referring to Rep.Gr 87 - Charge the refrigeration system
- 3) Check/confirm the HVAC system is working to specification

4H0 959 126B (Supersedes to C level) - HVAC High pressure sensor
