Technical product information

| Topic | New Continental GT and GTC - Window drop glass concerns |

New Continental GT and GTC

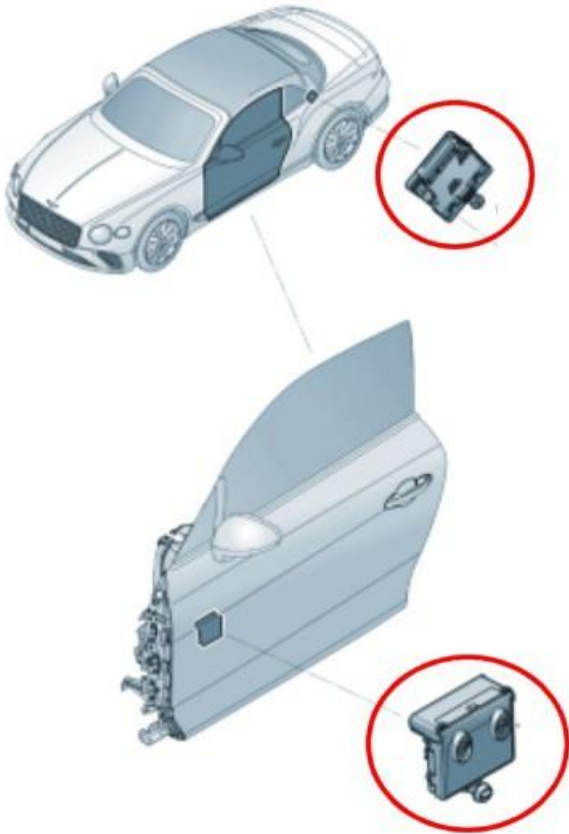
Figure 1

If the control modules are not all at "J" level suffix all door control modules must be replaced (Figure 1) Refer to the applicable Rep.Gr to gain access to the control modules (, the control module replace test (using ODIS) must also be carried out to completion before conducting Section 2

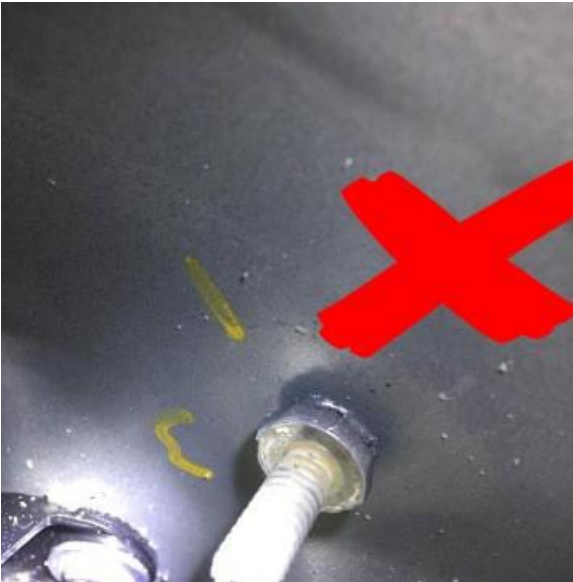
- Earth point 736 RHR and Earth point 738 LHR
- Check for cleanliness and security of both earth points Figure 2 shows an example of a contaminated earth point (dirt/paint/debris)

- Remove any dirt/paint/debris from the earth points using suitable abrasives/wire brush ensuring no damage is caused to the earth stud threads as shown in Figure 3

- Secure the earth point fixings to (9Nm)

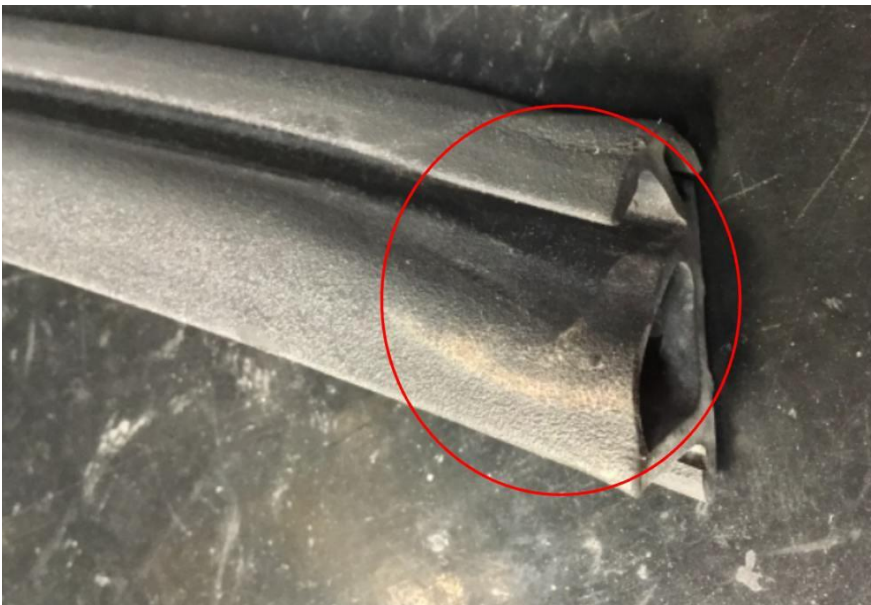
Figure 4

- Damage
- Splits
- Tears
- Misalignment
- Incorrectly fitted/located
- Drop glass seal deformation (see Figures 4 and 5 as examples)

NOTE: Any issues found with the window seals must be rectified before conducting the remaining steps
