# Technical Service Bulletin

## 43 Rear suspension lowering does not work

43 22 67 2059841/3 August 3, 2022. Supersedes Technical Service Bulletin Group 43 number 22-64 dated July 8, 2022, for reasons listed below.

Model(s)	Year	VIN Range	Vehicle-Specific Equipment
Q7	2017 – 2023	All	Not Applicable
Q8	2019 – 2023		
SQ7, SQ8, and RS Q8	2020 - 2023

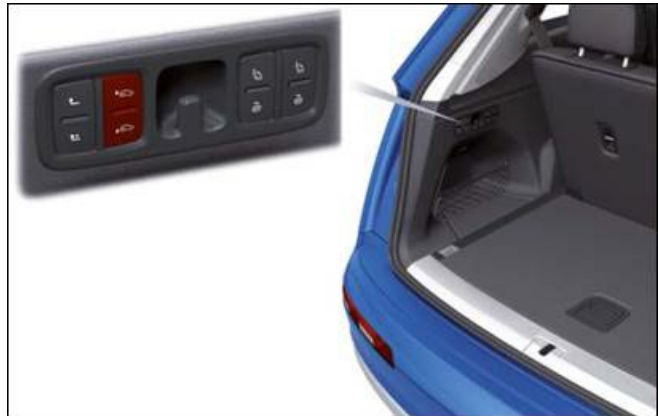
If the button for the rear suspension lowering is unintentionally operated when driving (for example by objects moving in the trunk area), the rear suspension lowering is sporadically not available (Figure 1).

*Figure 1. Location of the controls for lowering the rear suspension.*

1. Explain the functionality of the system to the customer, including the possibility of unintentionally operated when driving.
2. Clear the DTCs and release the vehicle.

Do not replace the J775 or the button for the rear suspension lowering or any other component in the vehicle.
