# News Channel Update | Vans Customer Service and Parts

Campaign No. 2022050016 June, 2022

SUBJECT: **Model 907 Model Year 2019-2020  
Retrofit Propeller Shaft Holder Bracket**

MBAG, the manufacturer of Mercedes-Benz Sprinter vehicles, determined that the holder brackets that are welded onto the cross member for the propeller shaft intermediate bearing may be missing on certain vehicles. As a result, the propeller shaft intermediate bearing may not have been installed at the specified position.

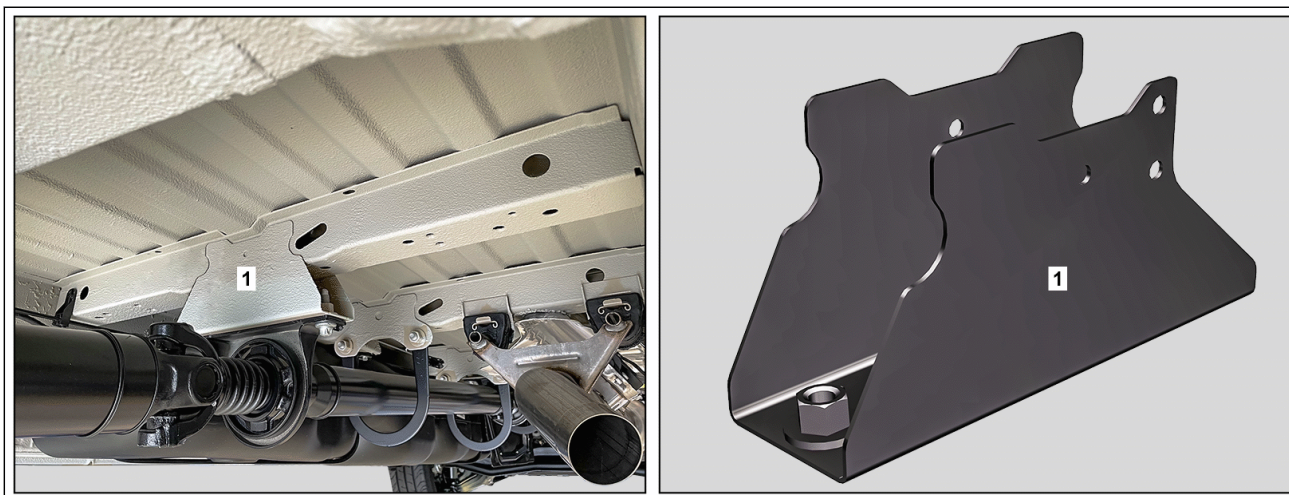
D41.10-A028-78

1 Bracket

<b>Install</b>		
5  WS	Retrofit holder (1) for propeller shaft.  000 588 02 84 00 Welder	Clip: Retrofit holder for propeller shaft on crossmember   <b>Commercially available devices/ tools</b> Clamping pliers (Standard) Rotary wire brush Drill bit 7 mm Wet and dry vacuum cleaner	<a href="#">Page 9</a>  <a href="#">Page 5</a>  WS60.00-P-0022K
6	Clean weld joints and sheet metal flange.	 <b>Commercially available devices/ tools</b> Rotary wire brush	
7	Remove welding protection blankets.	 <b>Commercially available devices/ tools</b> Welding protection blanket	
8	Clean repair area.	 <b>Commercially available devices/ tools</b> Wet and dry vacuum cleaner	
9 Notice	<b>Danger</b> <b>Risk of explosion</b> caused by paint vapors igniting. <b>Risk of poisoning</b> caused by inhaling paint vapors.  Prime repair area with primer filler. Notes on paintwork repairs	No smoking! No open fire! Use respiratory protection, protective clothing, gloves, safety glasses and protective skin cream. Ensure that the area is well ventilated.   Use only primer fillers approved by manufacturer. See guidelines for paint technology in the workshop portal.	AS98.00-Z-0002-01A  AH98.00-P-9408-02A
