GROUP	MODEL
ELE	2017-2018MY Sedona (YP)
NUMBER	DATE
259	August 2022

TECHNICAL SERVICE BULLETIN

SIDE AIRBAG (SAB) WARNING LIGHT ON WITH DTC(S) B1378/B1382

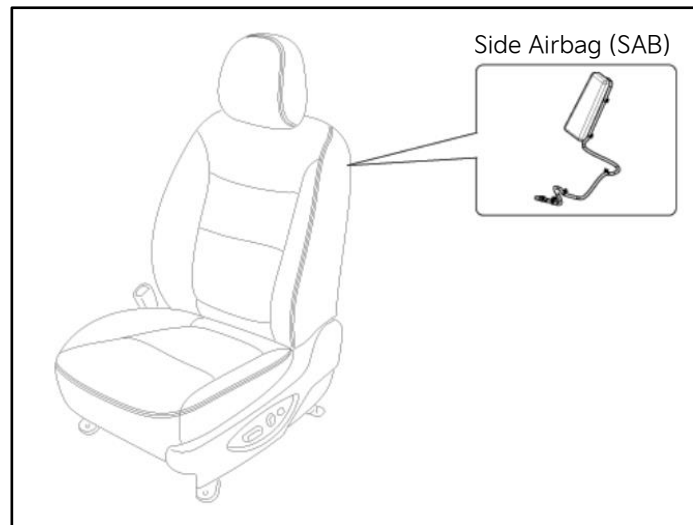
This bulletin provides information associated with the 'Warranty Extension Program' (WTY025) to diagnose and repair certain airbag warning light 'ON' conditions for 2017-2018MY Sedona (YP) vehicles produced from March 16, 2016 through December 6, 2017. The affected vehicles may exhibit an airbag warning light 'ON' with DTC B1378 and/or B1382 due to the front seat Side Airbag (SAB) connector experiencing higher than normal resistance. Follow the procedure outlined in this publication to inspect for DTCs and reconnect the side airbag connector of the affected front seat depending on the DTC defined below.

- B1378 - Side Airbag Front Driver Resistance Too High
- B1382 - Side Airbag Front Passenger Resistance Too High

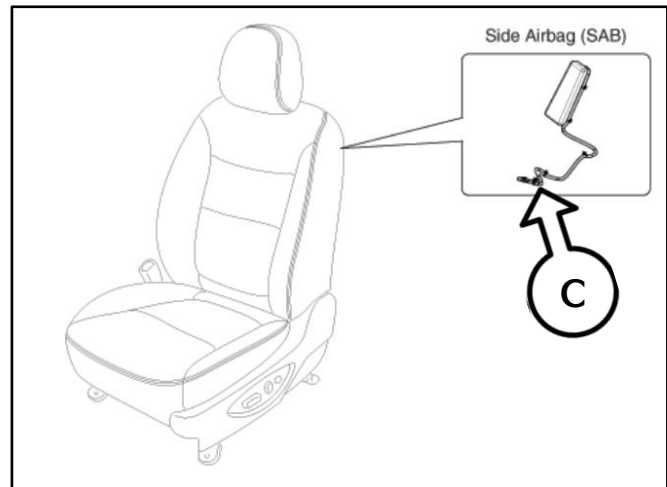
- Using KDS, scan the airbag system and confirm if one or both of the following DTC(s) are present

- B1378 - Side Airbag Front Driver Resistance Too High
- B1382 - Side Airbag Front Passenger Resistance Too High

If the stored DTC(s) IS either B1378 and/or B1382, then proceed to the 'Repair Procedure' on page 3 to check the SAB connector.
