Customer Satisfaction Program

N212354523 Heated Vented Seats Retrofit Due to Chip Shortage

Release Date: August 2022

Revision: 00

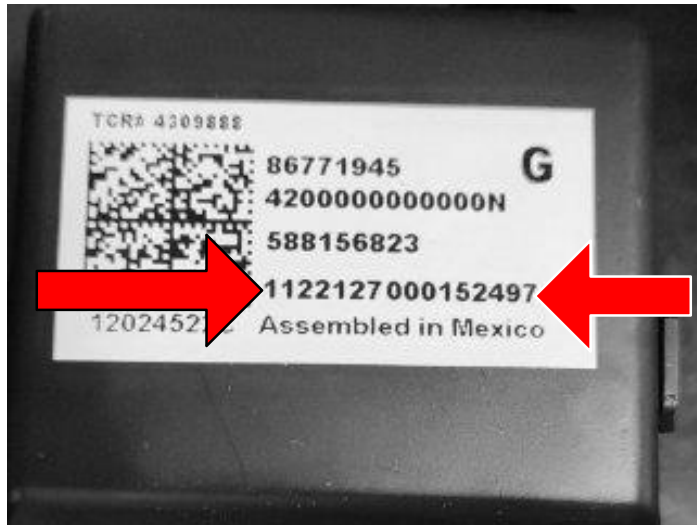
Record the serial number on the front and rear seat heater vent control module labels.

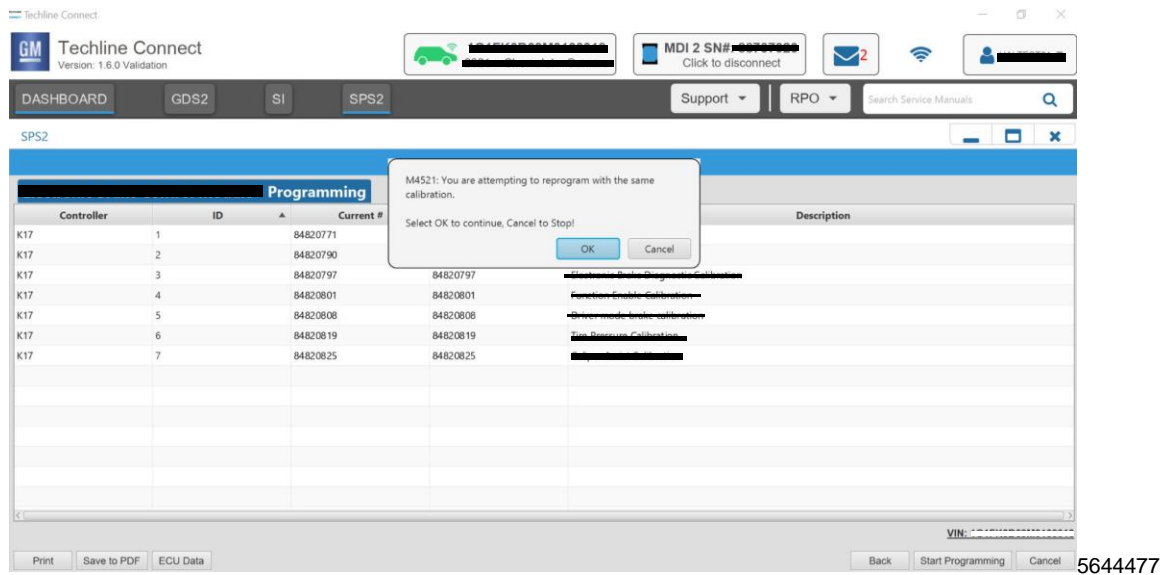
Important: Techline Connect screens shown above.

Important: If the same calibration/software warning is noted on the TLC Summary screen, select OK and follow screen instructions. After a successful programming event, the WCC is located in the Service Programming System dialogue box of the SPS Summary screen. No further action is required. Refer to the Warranty section of the bulletin.

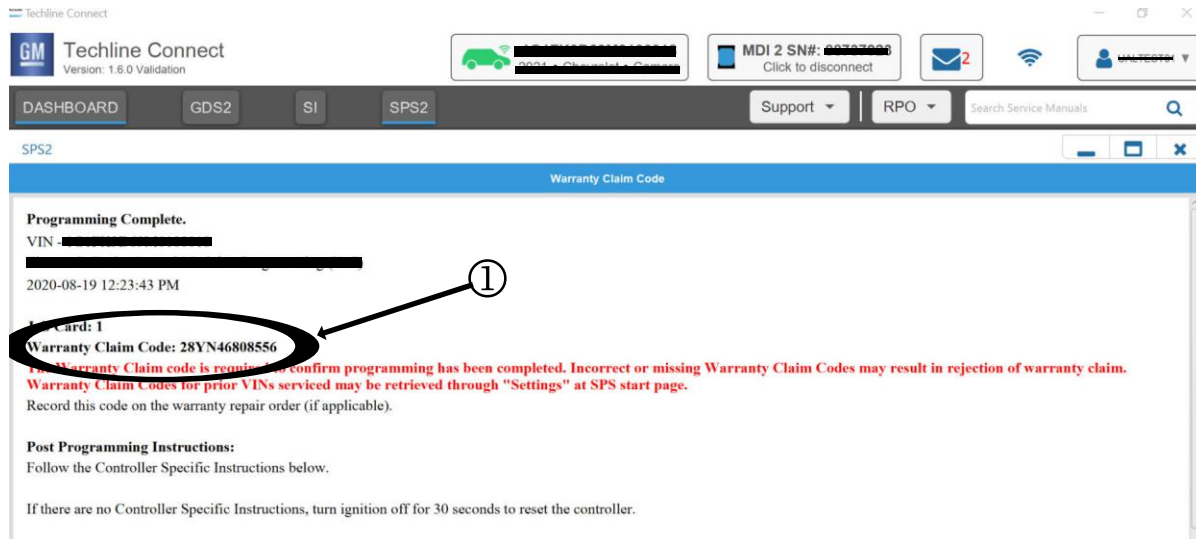
Note: The screenshot above is an example of module programming and may not be indicative of the specific module that is being programmed. Module selection and VIN information have been blacked out.

Important: To avoid warranty transaction rejections, you MUST record the warranty claim code provided on the Warranty Claim Code (WCC) screen shown above on the job card. Refer to callout 1 above for the location of the WCC on the screen.

11. Record SPS Warranty Claim Code on job card for warranty transaction submission.
