Bulletin No.: PIT4261H
Published date: 07/1/2022

PIT4261H Tire Sidewall Irregularities

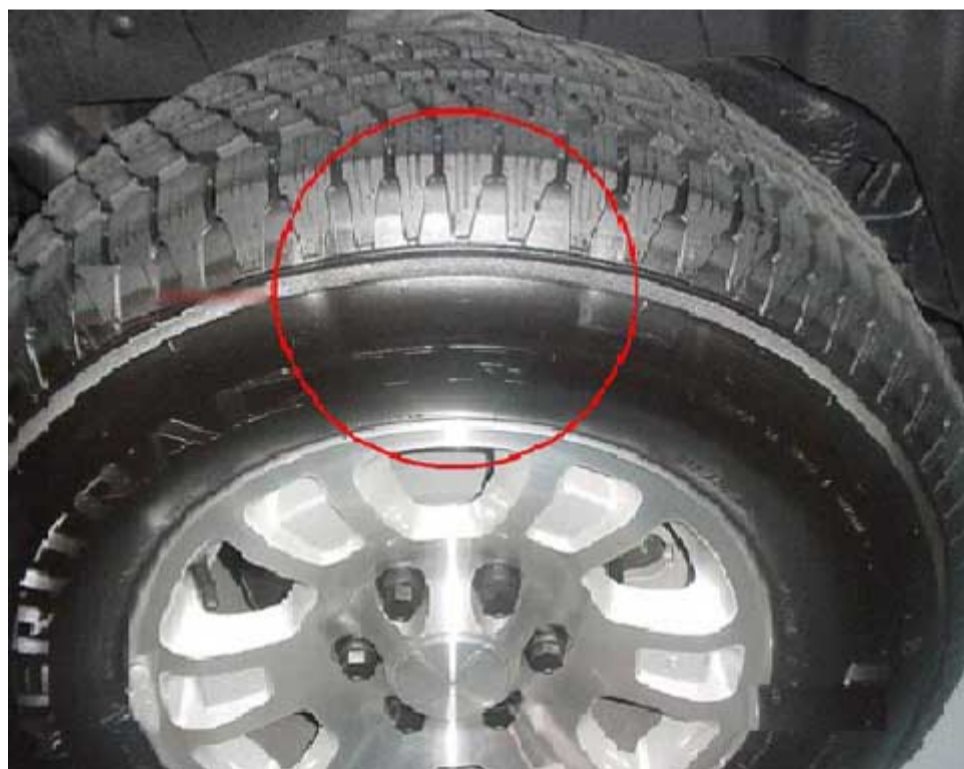
Slight sidewall indentations are a common characteristic of radial tire construction. These indentations are more noticeable on larger size tires having a larger side wall height. Radial tire body construction includes individual cords that run parallel to each other from bead to bead (down the sidewall, across the tread and up the other sidewall). These cords will overlap at points on the circumference of the tire. When the tire is mounted and inflated, it is free to naturally expand. The overlapped areas may create slight indentations, undulations, or protrusions since the stretching capacity of the overlapped area is slightly different than the rest of tire sidewall area.

The following two photo's show examples of tires with a sidewall indentation.

This is a visual condition that will not affect durability, reliability or performance of the tires. Tire replacement to address this condition is not recommended and will lead to customer dissatisfaction as the replacement tires will likely have the same or similar condition.
