## PIC6447A Water Leak - Passenger Side Carpeting May Be Wet When Using the Air Conditioning

Brand:	Model:	Model Years:	VIN:		Engine:	Transmissions:
			from	to		
Chevrolet	Corvette	2020 - 2023	All	All	All	All

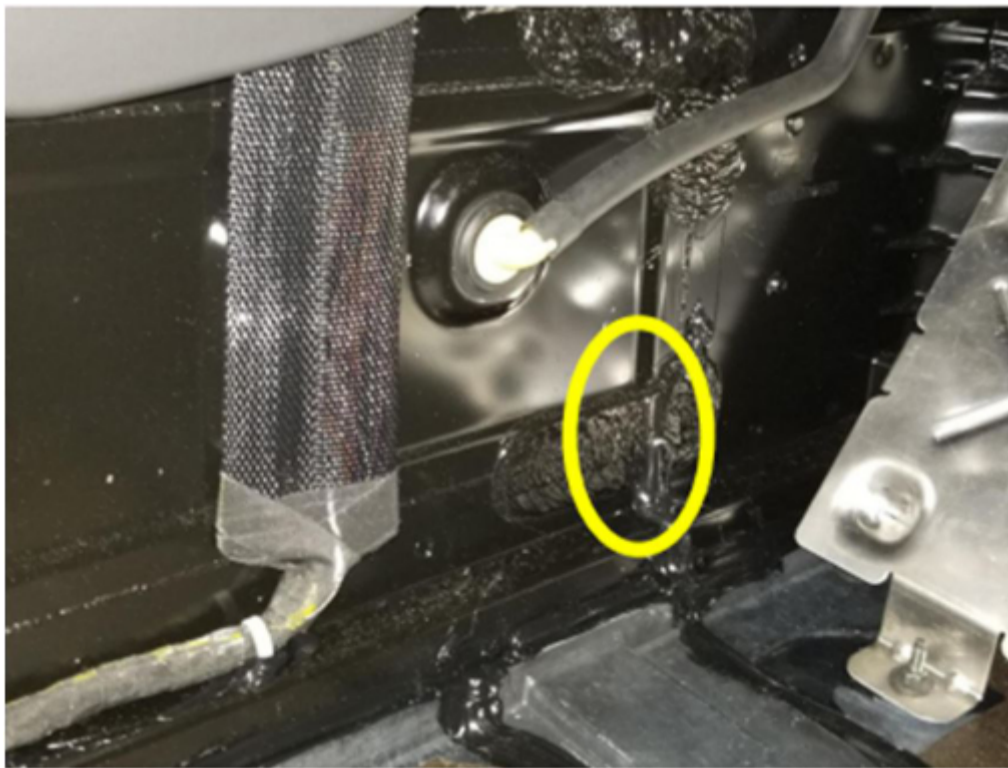
Condition #2 - As previously mentioned, even if an issue was found with Condition #1, all service technicians should also inspect / water test the vehicle for BOTH conditions listed in this document. Another leak point that has been identified on this vehicle is a seam between two body panels that is located just fore and several inches below where the AC drain tube exits the vehicle. This area can be seen in the photo below.

A gap in the seam sealer along this location may also allow water from the AC drain system to leak back inside the vehicle. To correctly repair this leak, a two-step approach is taken. First, the technician must seal the seam between the two body panels INSIDE the vehicle with seam sealer, available from any local body shop. Once that has been done, technicians are to seal the OUTSIDE of the vehicle to prevent water from getting to this area in the first place. To begin, first lift the car and remove the Floor Panel Tunnel Panel Front Reinforcement (currently found on SI document ID 5358807.) This is the long, narrow panel that covers the area historically referred to as the "transmission tunnel." This will allow access to the "outside" of the panels where the water is leaking in at.

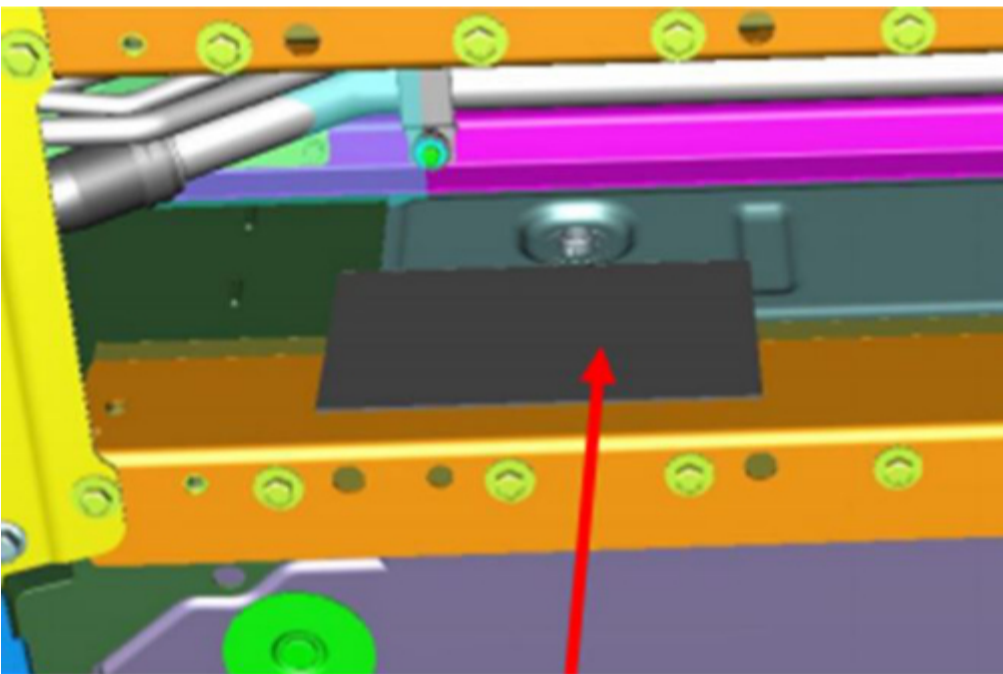
Once this panel has been removed, stand in the middle of the vehicle facing the front of the car. If you look upwards and to the right, you will see the AC drain tube exiting the center console area of the vehicle. Just below this AC drain tube, the technician is to inspect for the presence of a black mastic patch that is covering the seam between these two body panels. This patch can be seen in the computer image seen below.

The patch may or may not be present on the particular vehicle that is being serviced. It was not added at the assembly plant until later built vehicles. If the patch is not present, obtain a large piece of mastic from the parts department and apply it to the body so that this seam area is completely covered. Use the image above as a guide for size and placement. Be sure to wet out the patch correctly, using a roller, or a large socket. This will ensure that the adhesive is completely sealed to the body panels and no water may enter the vehicle in this location. If there already is a black mastic patch present in this location, it should be removed and replaced with a new one. Install the new patch following the same directions as listed above. This two-step repair will provide assurance that no further water leaks will occur in this area again.
