Bulletin No.: PIT5853A
Published date: 07/25/2022

PIT5853A Rattle Noise from Driver's Side Dash Area

Brand:	Model:	Model Years:	VIN:		Engine:	Transmissions:
			from	to		
Chevrolet	Silverado 2500HD/3500HD	2020 - 2023	All	All	All	All
GMC	Sierra 2500HD/3500HD	2020 - 2023	All	All	All	All

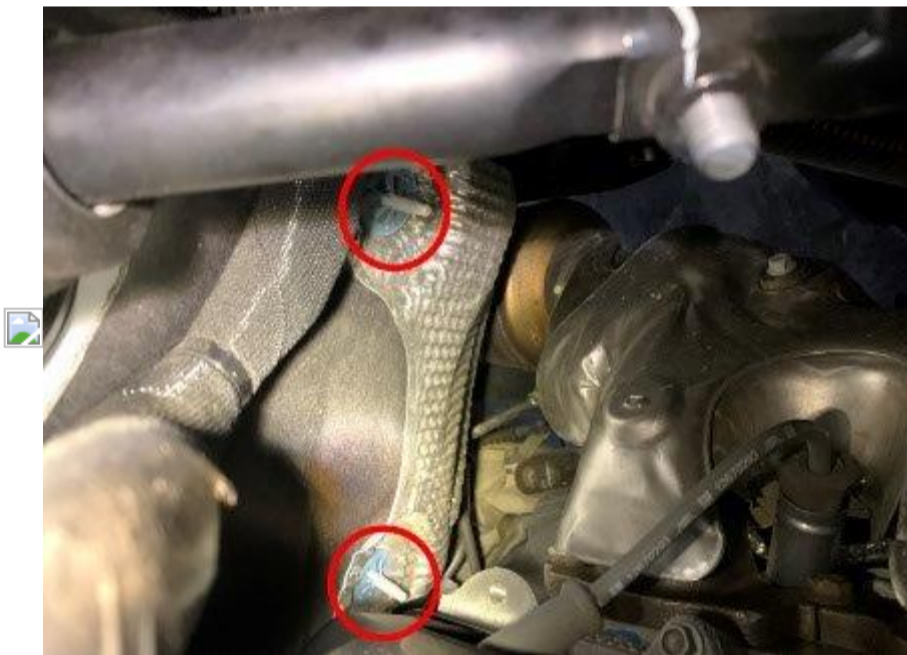
Involved Region or Country	North America
Condition	Some customers may comment on a rattle noise from the driver side dash area in park at idle or while driving.
Cause	The retainer clips that hold the Exhaust Front Underbody Heat Shield may have become loose, shown below.

Remove existing retainer clips and replace with updated retainer clip P/N 13232779 and tighten by hand until heat shield is secured into position.
