# Preliminary Information

## PIT5847E SES Light - Reduced Power - DIC Warning Messages - Reduced Steering Message - Stabilitrack Message

Brand:	Model:	Model Years:	VIN:		Engine:	Transmissions:
			from	to		
Cadillac	XT5	2019 - 2022	All	All	All	All
Cadillac	XT6	2020 - 2022	All	All	All	All
Chevrolet	Blazer	2019 - 2022	All	All	All	All
GMC	Acadia	2019 - 2022	All	All	All	All

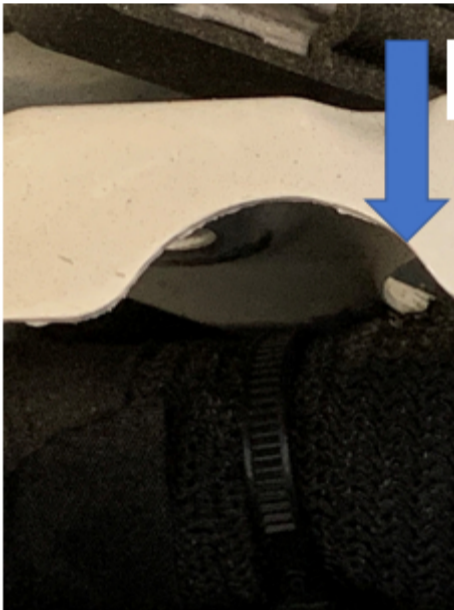
Close up of area where harness may chafe.

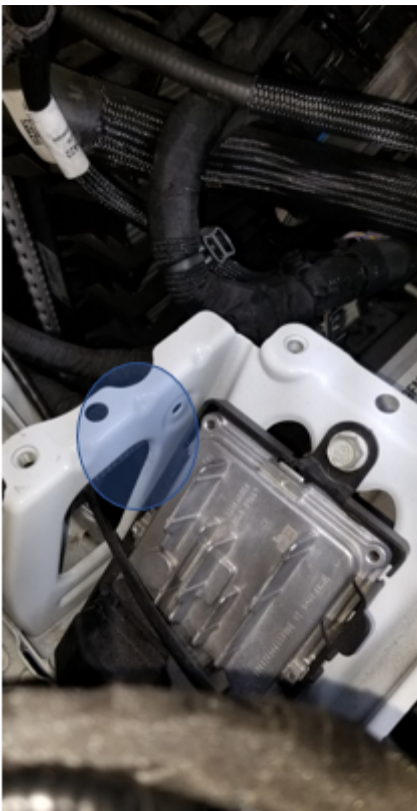
Harness may chafe in the areas shown in the photos above and below.

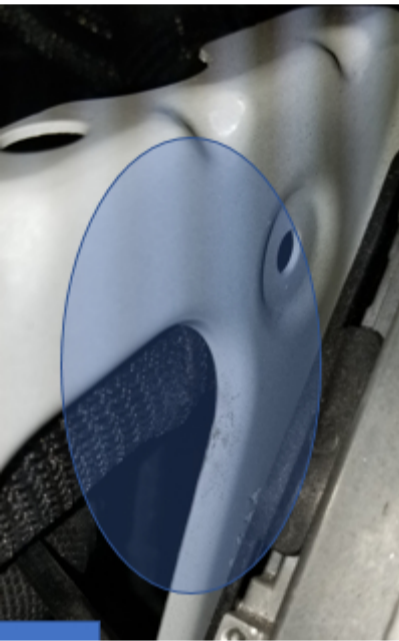
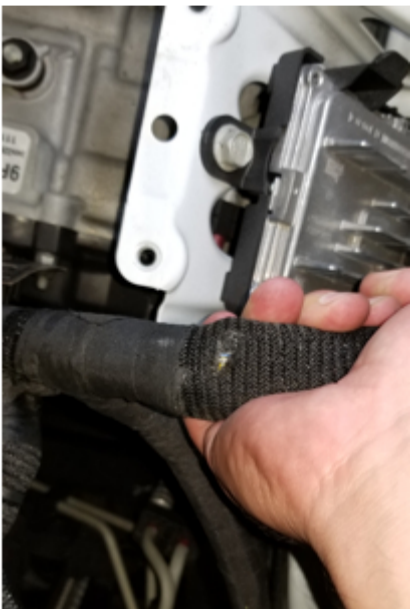
Above shows a harness that was chaffed by the bracket.
