## PIT5934 Diagnostic Tip - Low Airflow From Rear HVAC Vents

Brand:	Model:	Model Years:	VIN:		Engine:	Transmissions:
			from	to		
Chevrolet	Silverado 1500 New (RPO J22, VIN Digit 5 = A / D)	2022	All	All	All	All
GMC	Sierra 1500 New (RPO J22, VIN Digit 5 = H / U)	2022	All	All	All	All

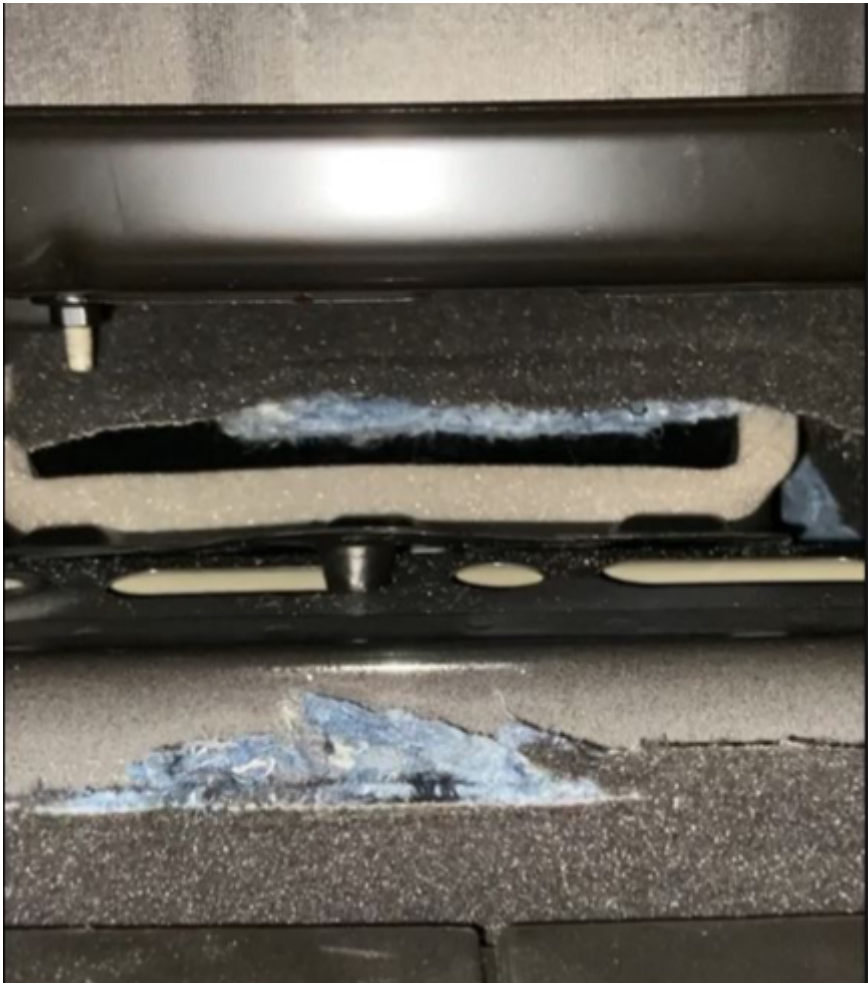
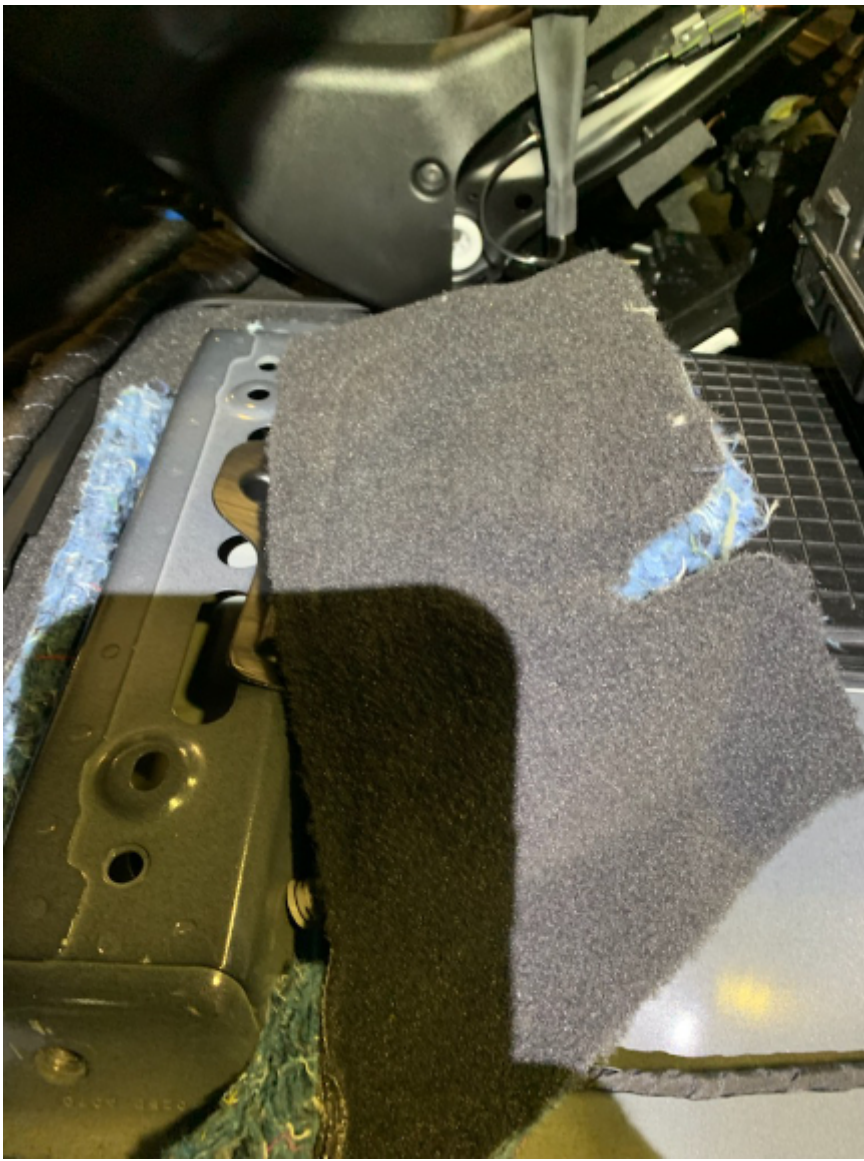
Involved Region or Country	North America
Condition	A customer may comment that there is low airflow from the rear HVAC vents.
Cause	The floor carpet may be mispositioned over the rear HVAC duct under the center console / center seat blocking airflow.

Pictures showing carpet mispositioned blocking rear HVAC ducting

Inspect for floor carpet blocking rear HVAC duct. Reposition floor carpet as necessary to ensure it does not block rear HVAC duct.

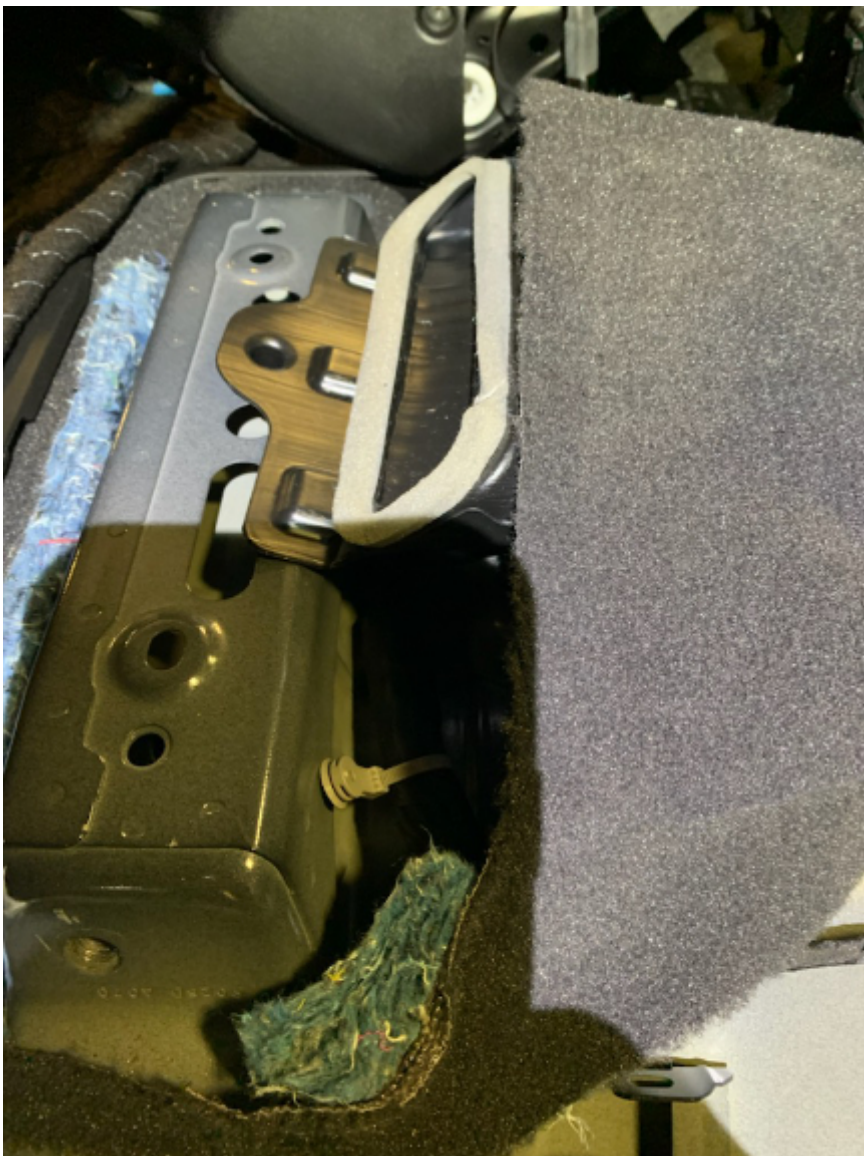
Picture showing carpet positioned correctly
