# Emissions Recall

## Code: 26M4

<b>Subject</b>	Catalyst															
<b>Release Date</b>	August 10, 2022															
<b>REVISION SUMMARY</b>	<p>Removed requirement for adding a zip tie to the catalyst core</p> <p><b>REMINDER: The catalysts MUST be separated from the exhaust system for recycling.</b></p>															
<b>Affected Vehicles</b>

**Subject: Emissions Recall 26M4 - Catalyst**

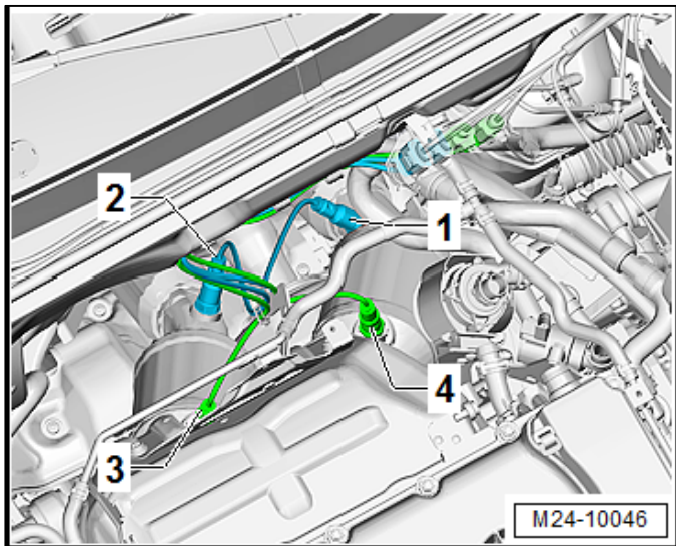
Oxygen sensors <1>, <3> and <4> can be removed with tools from the Ring Wrench 7-Piece Set -3337-.

Oxygen sensor <2> will have to be removed with a locally sourced oxygen sensor socket.

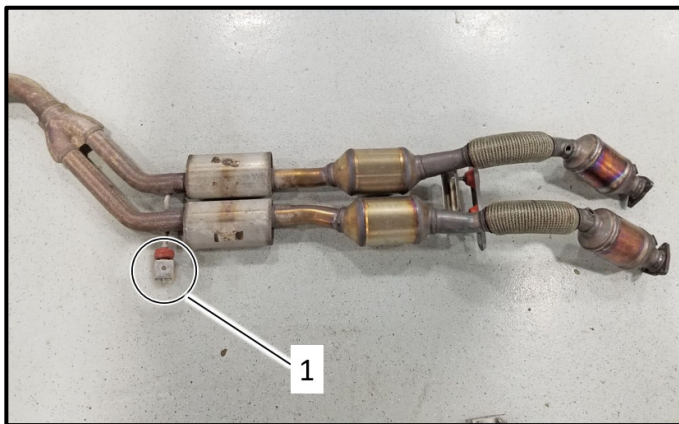
**Danger of causing damage to the decoupling element!**

Do not bend the decoupling element more than 10°. Do not damage the wire mesh on the decoupling element.

- Ensure the transportation protection <1> is secured on the new catalyst before installing.
- After installing and securing the catalyst to the exhaust manifold, remove the transportation protection from the catalyts.

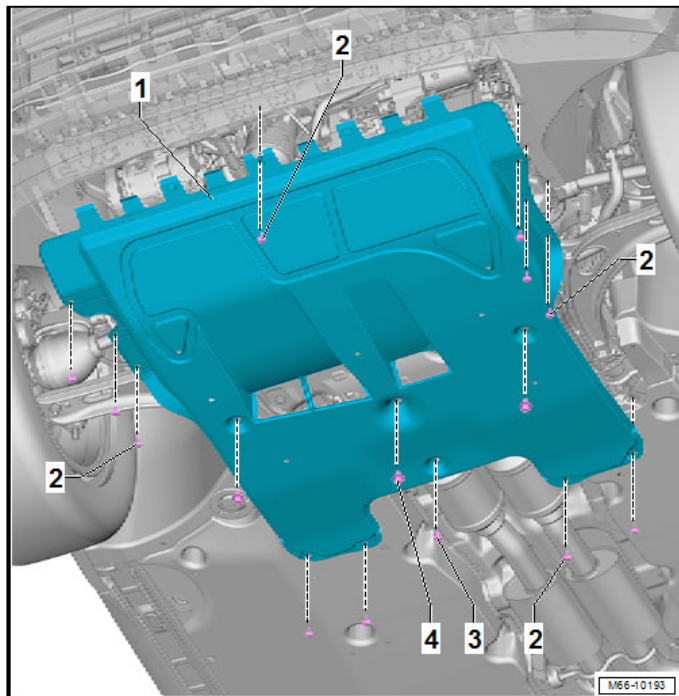
This rivet is required to prevent noise and to prevent debris from building up on the top of the noise insulation.

- If the new catalyst is not equipped with a rear hanger, transfer the rear exhaust hanger <1> from the removed catalyst to the new catalyst.

- A new expanding rivet <3> must be installed when reinstalling the noise insulation.
