# Emissions Recall Code: 26N6

Catalyst

August 10, 2022

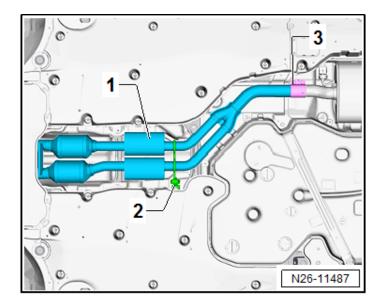
Over time and mileage, the factory-installed catalyst may not perform as required. If the effectiveness of the catalyst is reduced, this may result in increased tailpipe emissions and the vehicle could fail an emissions (IM) inspection.

Replace catalyst and update ECM software.
