ATTENTION:
THIS IS A TECH TIP, NOT A TECHNICAL BULLETIN AS TITLED.
TECH TIPS ARE NOT ASSOCIATED WITH WARRANTY CLAIMING.

Applicable Vehicles					
Model(s)	Year	Eng. Code	Trans. Code	VIN Range From	VIN Range To
All	2015-2023	All	All	All	All

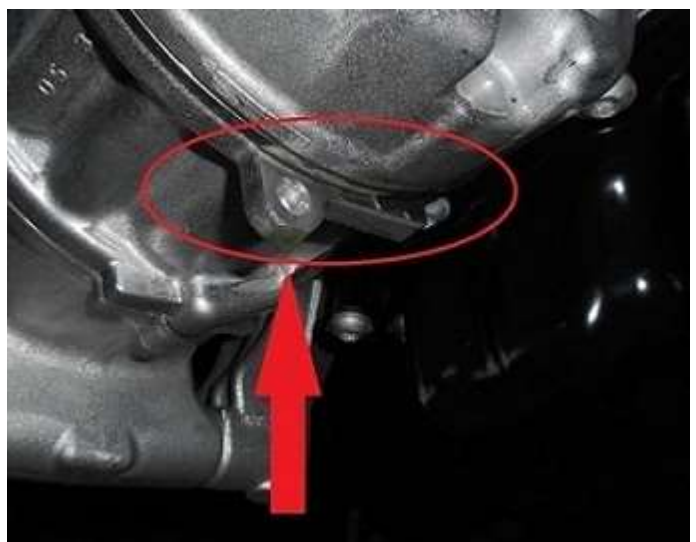
Figure 1

While verifying a low refrigerant condition the -**V454**- Air Conditioning Compressor sometimes appears to be leaking at the case seals (Figure 1).

The oil found at the bottom of the compressor (Figure 1) can be caused by a leaking low pressure compressor O-ring. (Figure 2-3).

Oil found at bottom of compressor.

Before the replacement of any compressor for a possible leak the leak must first be verified by injecting dye into the Air Conditioning system after refrigerant recovery to verify the refrigerant level.

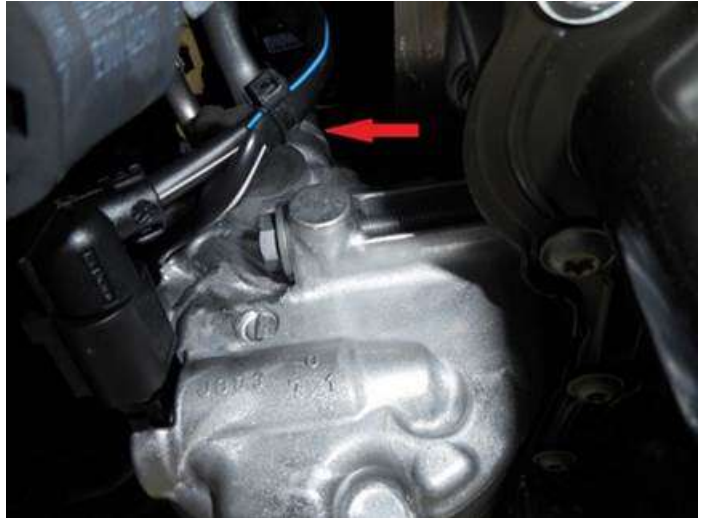
Figure 2

Leak found at low pressure compressor connection.

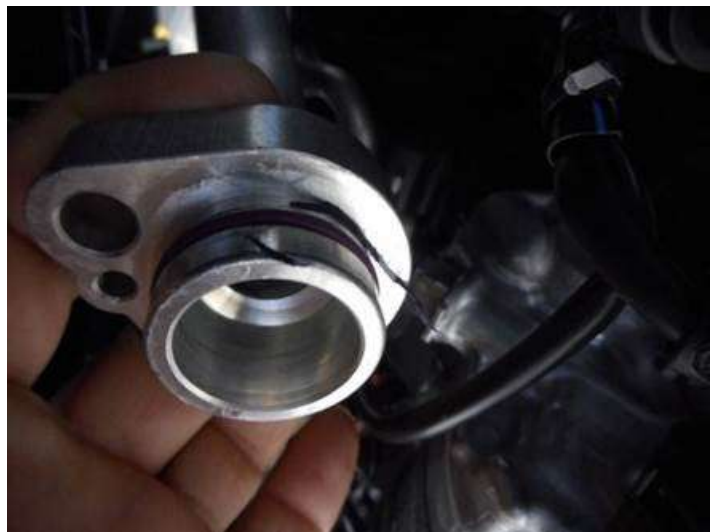
Figure 3

Cause: O-ring torn on low pressure AC hose connection to compressor.
