# Product Emission Recall

## N222370150 LFV ECM Calibration incorrect for Engine due to ECR Coordination Incorrect Breakpoint

**Release Date:** August 2022

**Revision:** 01

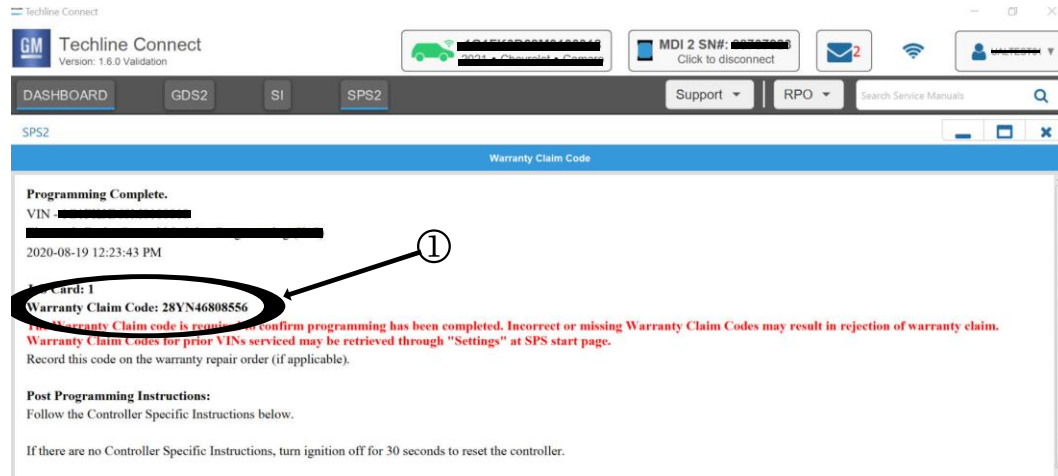
5644478

**Note:** The screenshot above is an example of module programming and may not be indicative of the specific module that is being programmed. Module selection and VIN information have been blacked out.

**Important:** To avoid warranty transaction rejections, you **MUST** record the warranty claim code provided on the Warranty Claim Code (WCC) screen shown above on the job card. Refer to callout 1 above for the location of the WCC on the screen.
