# Service Bulletin

Bulletin No.: 20-NA-136

**Subject:** Diagnostic Tips for DTCs Set at a Low Mileage for 9T65 Transmissions

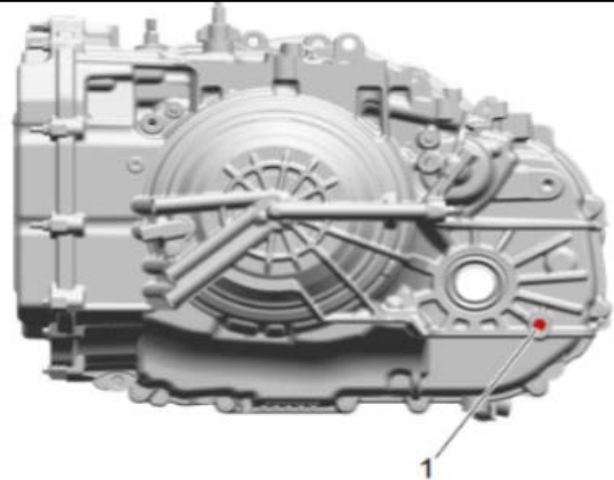
5619626

6. While the vehicle is idling, remove the oil level set plug (1). Allow any fluid to drain:
  - If the fluid is flowing as a steady stream, wait until the fluid begins to drip.
  - If no fluid comes out, add fluid until fluid drips out.
7. Record fluid level; overfilled, under-filled, correct on repair order and how much was needed to fill or came out:
  - If fluid is overfilled, set correct level and retest.
  - If fluid is under-filled, inspect for external leaks. Refer to *Fluid Leak Diagnosis*.
8. If fluid level is correct, then check condition of the fluid.

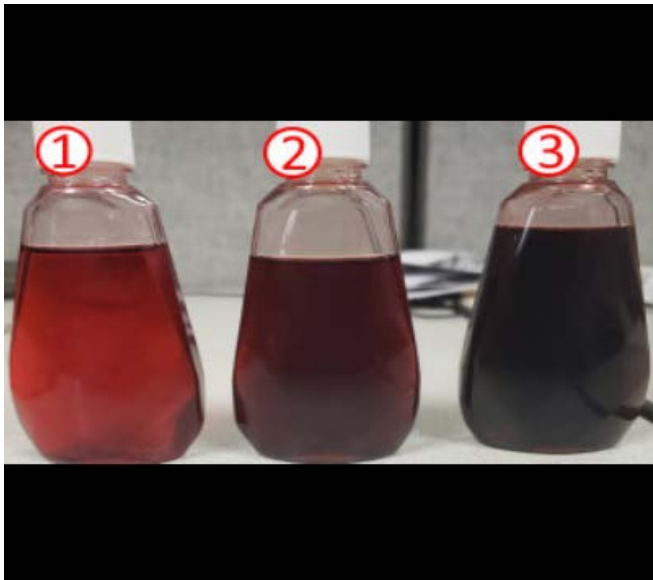
5840393

- The fluid should be red or dark brown.
- It should be transparent so that objects or writing can be seen through it. Sample #1 is an example of acceptable fluid. Sample #2 is an example of very dark fluid. Sample #3 is an example of black fluid.
- In addition to checking the fluid color and transparency, the fluid should be checked for an odor of burnt fluid. If the fluid is very dark, black, or has a burnt odor it would indicate clutch damage has occurred internally in the transmission and it would need to be removed from the vehicle and investigated.
