Service Bulletin

Bulletin No.: 21-NA-169

Date: August, 2022

Subject: Diagnostic Tip for DTCs Set at a Low Mileage for 9T45/50/60 Automatic Transmissions

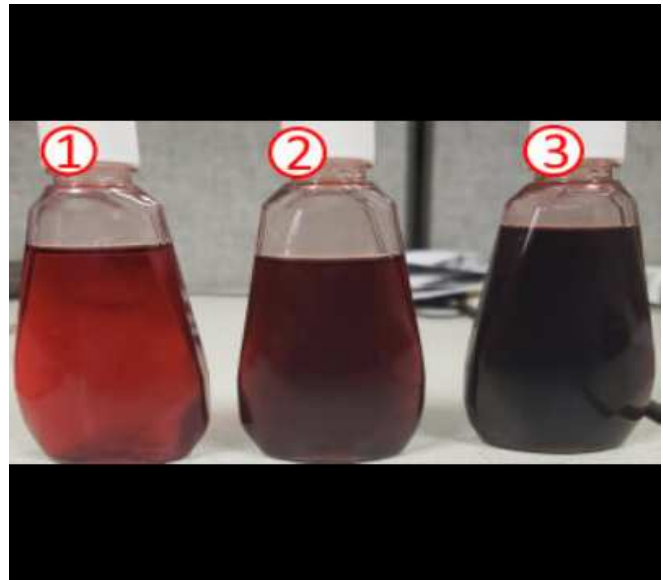
5840393

9. If fluid level is correct, then check condition of the fluid:
 - The fluid should be red or brown.
 - The fluid should be transparent so that objects or writing can be seen through it. Sample #1 is an example of acceptable fluid. Sample #2 is an example of very dark fluid. Sample #3 is an example of black fluid.

- In addition to checking the fluid color and transparency, the fluid should be checked for an odor of burnt fluid. If the fluid is very dark, black, or has a burnt odor it would indicate clutch damage has occurred internally in the transmission and it would need to be removed from the vehicle and investigated.
