Service Update

N222358050 Right Side Overhead Console and Rear Reading Lamps Inoperative

Release Date: August 2022

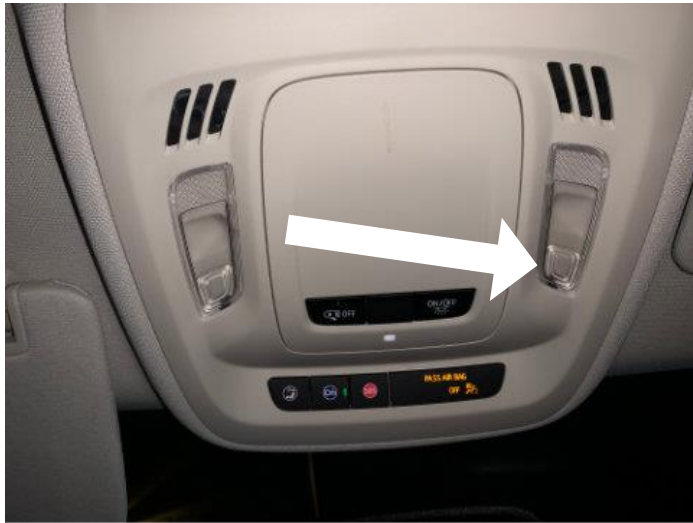
5994572

Condition	Certain 2022 model year Buick Envision vehicles have software that had an unwanted effect resulting in the right-hand reading lamps (OHC and rear) not illuminating when manually switched on.
Correction	Dealers are to inspect for OHC right reading lamp function and replace if necessary.

2. Press the RH reading lamp button.
3. Confirm the reading lamp illuminates.
 - If the RH reading **lamp illuminates**, no further action is required.
 - If the RH reading **lamp does not illuminate**, proceed to step 4.
4. Replace the roof console. Refer to *Roof Console Replacement* in SI.
