# Technical Service Bulletin

## 87 Noise from the air conditioning compressor when the AC is active

87 22 31 2063467/4 August 11, 2022. Supersedes Technical Service Bulletin Group 87 number 22-26 dated April 20, 2022, for reasons listed below.

Model(s)	Year	VIN Range	Vehicle-Specific Equipment
e-tron quattro	2019 – 2023	All	Not Applicable
e-tron Sportback quattro	2020 – 2023

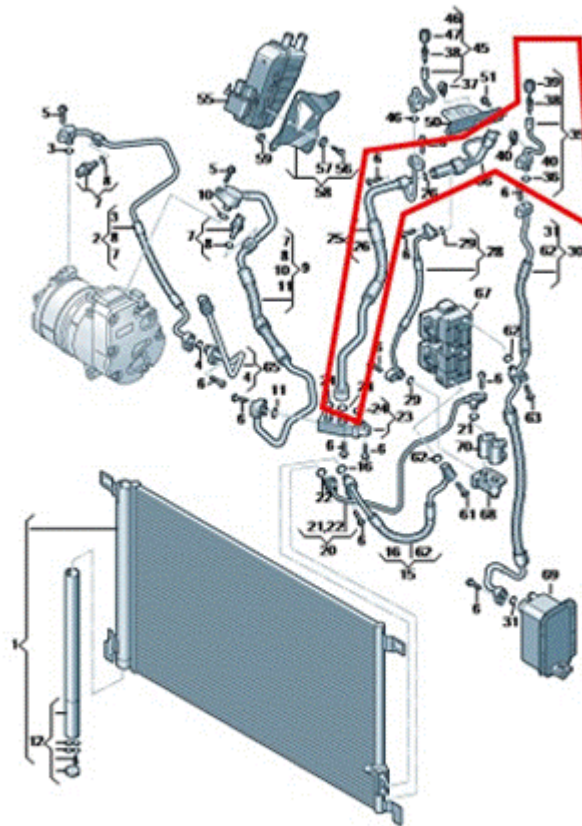
The source of this noise may be due to direct contact between adjacent refrigerant lines (Figure 1) or between a refrigerant line and the Bowden cable clip for the front hood release in the front motor compartment (Figure 2). When the air conditioning compressor is operating the noise created by the vibration is transferred from this point of contact and into the cabin.

*Figure 1. The refrigerant lines possibly make contact.*

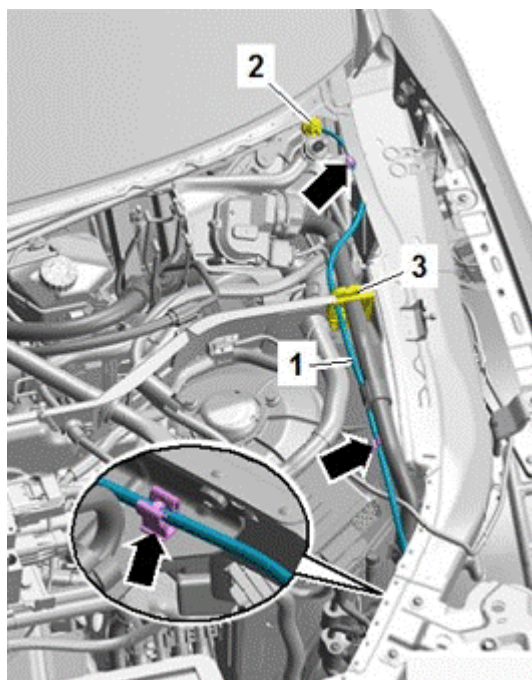
*Figure 2. Location of the Bowden cable clip for the front hood release.*

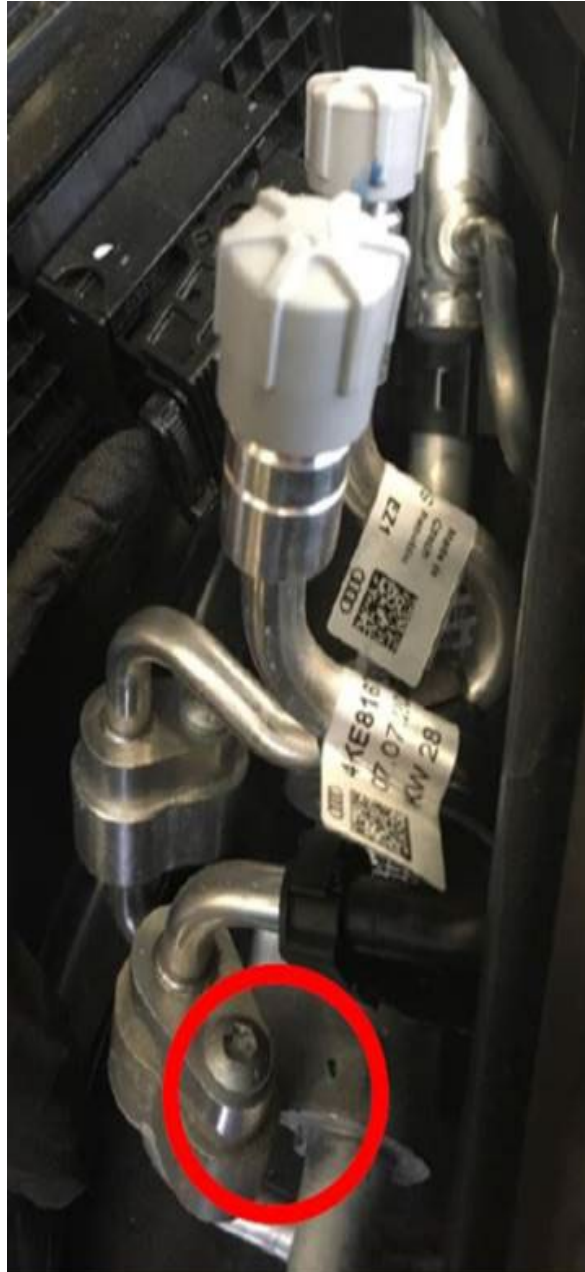
1. Figure 3 shows refrigerant lines close enough to make contact and elicit vibration transfer and noise.

*Figure 3. The refrigerant lines are making contact.*

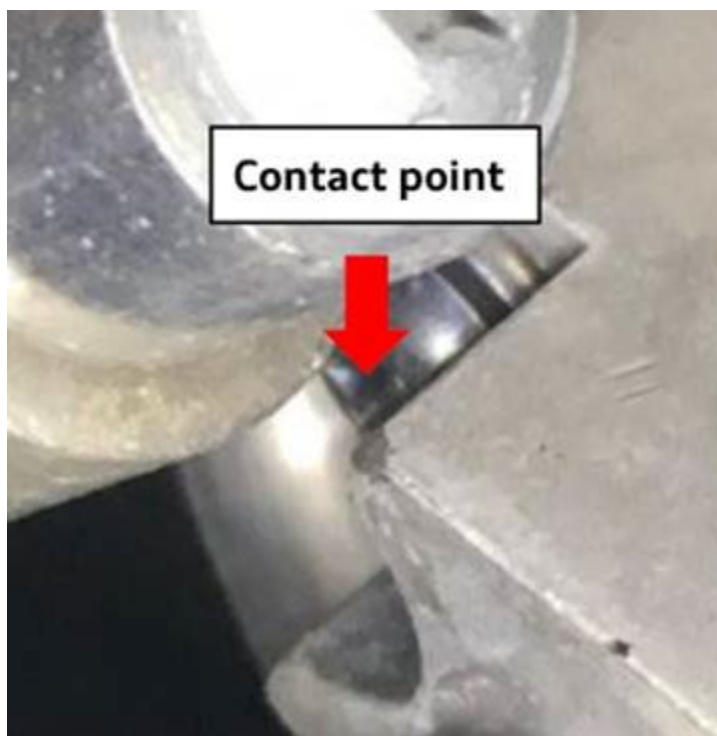
2. Figure 4 shows a close-up view of the point of contact.

*Figure 4. Point of contact.*

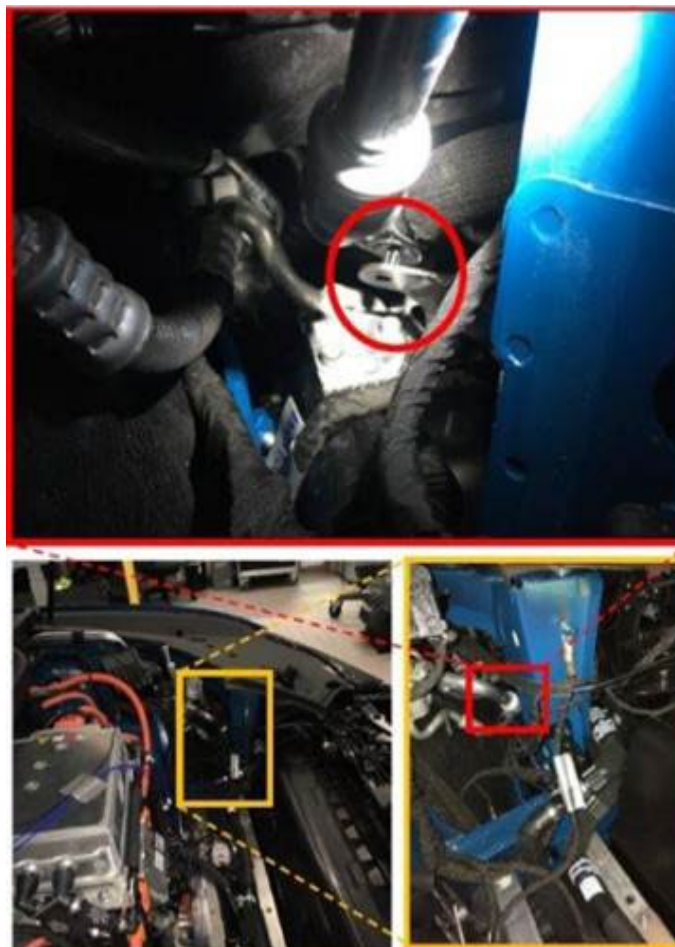
*Figure 5. The area in the motor bay where contacting lines are located.*

3. These refrigerant lines must be separated and, if necessary, retained in a separated position using a hose holder, clip, or tie-wrap (Figure 5).

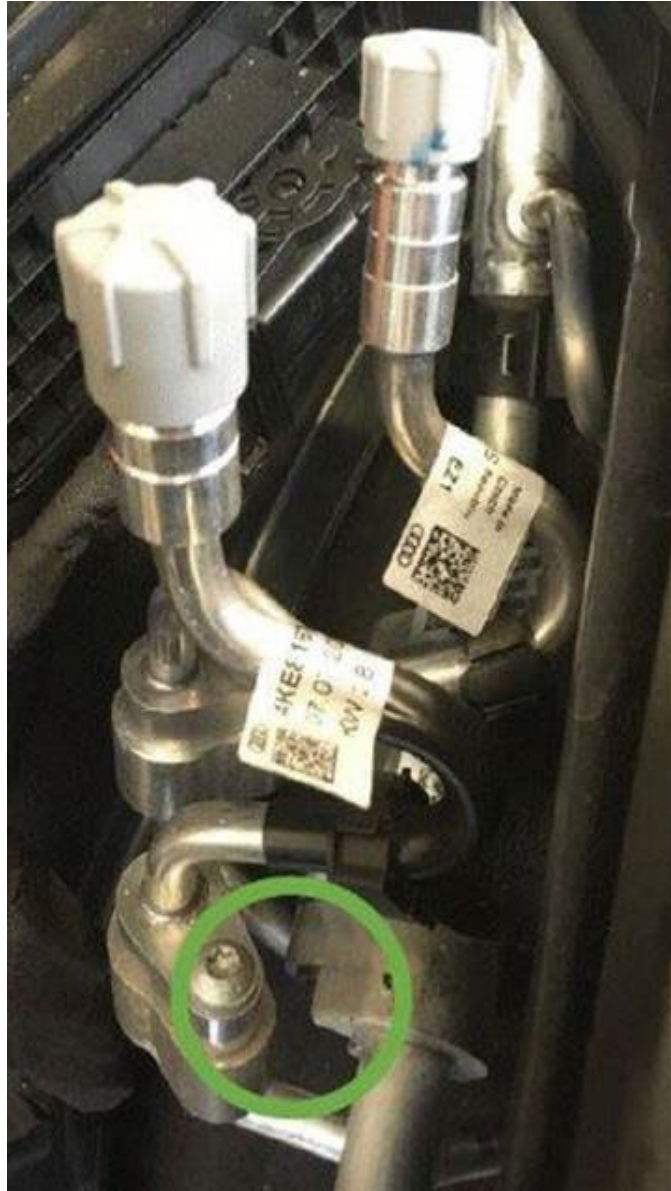
4. Figure 6 shows properly separated refrigerant lines.

*Figure 6. Refrigerant lines retained in a separated position.*

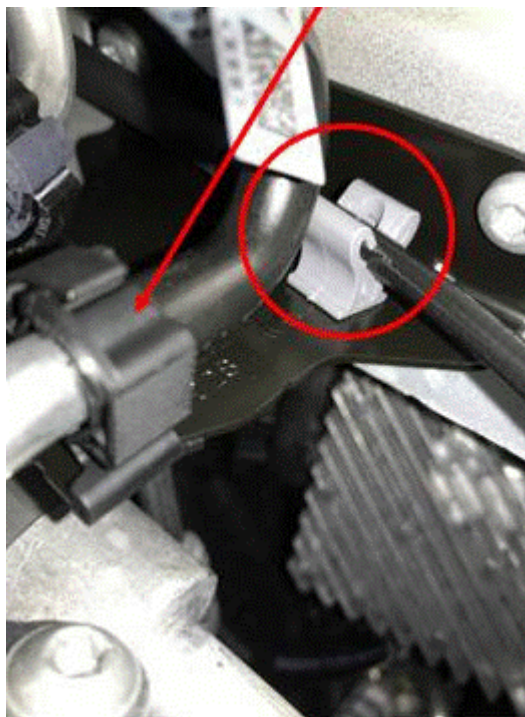
*Figure 7. Point of contact between refrigerant line and Bowden cable clip.*

5. An additional point of contact may be found between the refrigerant line containing the service port and the clip that retains the Bowden cable for the front hood release. If contact is found here these components must be separated and secured in a separated position. The retaining clip for the refrigerant line allows the line to slide within it. This is to be considered when securing the line away from the clip for the Bowden cable.

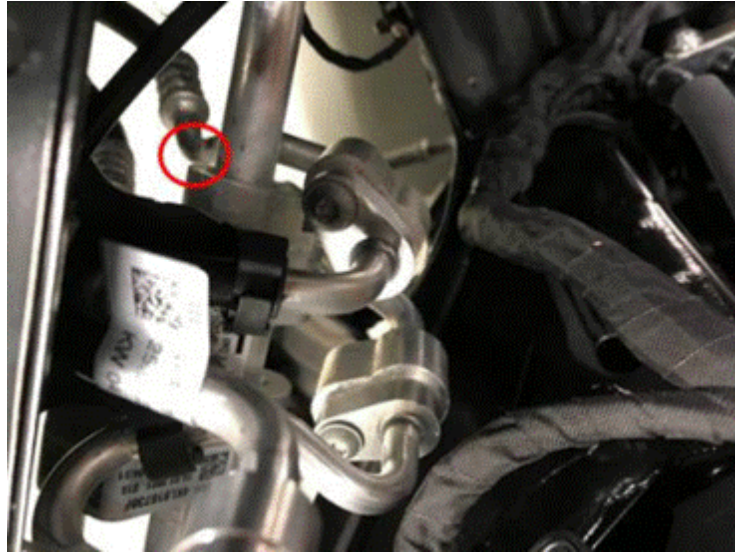
*Figure 8. Point of contact between coaxial refrigerant line and the refrigerant line containing the service port.*

6. Figure 8 shows an additional point of contact possible at the coaxial refrigerant line where it crosses the refrigerant line containing the service port. Again, separate and secure these lines in a separated position.

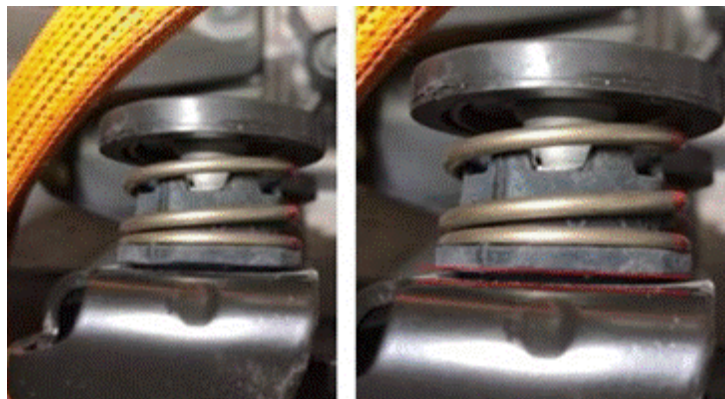
7. In some cases the compressor isolator spring is not indexed correctly in the rubber mounting causing an incorrectly seated compressor isolator assembly. Inspect the isolator / spring assembly for proper fit of the spring to the isolator at the top and bottom seating areas. Figure 9 shows a poorly seated isolator showing a gap between the rubber isolator and the mounting bracket.

*Figure 9. Poorly seated compressor isolator / spring assembly.*

8. The spring and / or rubber mount may need to be twisted to correct the spring to rubber mount index allowing the isolator assembly to lie flat against the bracket. Figure 10 shows a properly seated isolator / spring assembly.

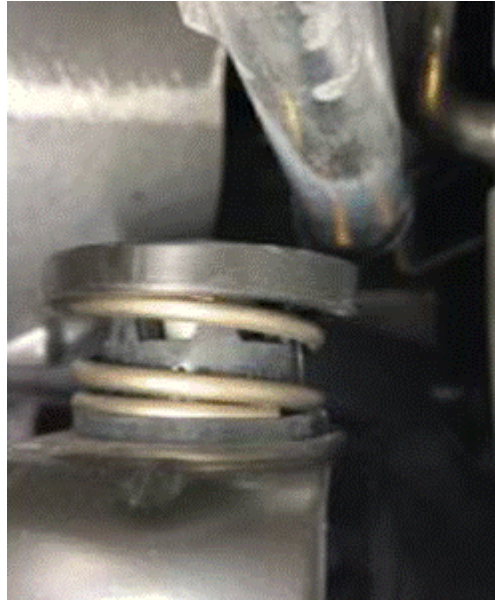
*Figure 10. Correctly seated compressor isolator / spring assembly.*

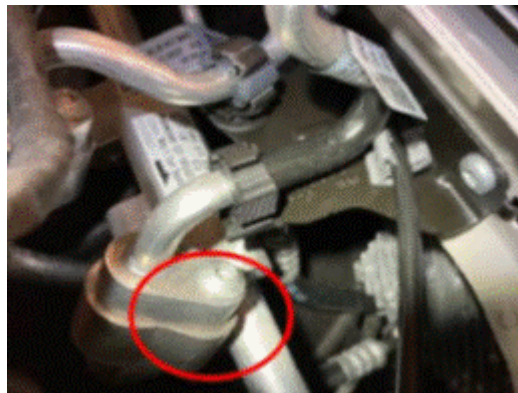
9. An additional possible point of line contact is the service port mounting block in Figure 11.

*Figure 11. Service port mounting interference with adjacent line.*

10. Correct this by pushing the service port in the direction of the arrow with just enough force to create a permanent clearance as shown in Figure 12.

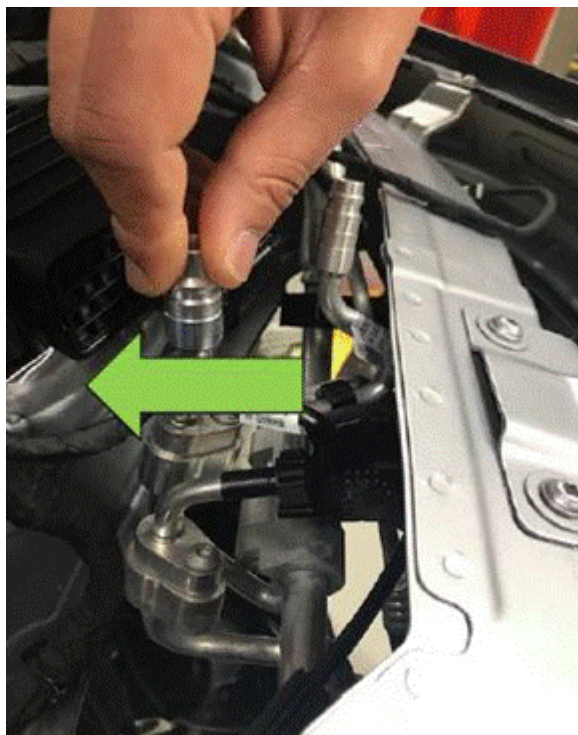
*Figure 12. Creating a permanent gap between the service port mounting and the adjacent line.*
