Technical Service Bulletin

90 Instrument cluster: the Audi virtual cockpit displays a colorful line (pixel error)

90 22 78 2064983/4 August 9, 2022. Supersedes Technical Service Bulletin Group 90 number 22-41 dated January 31, 2022, for reasons listed below.

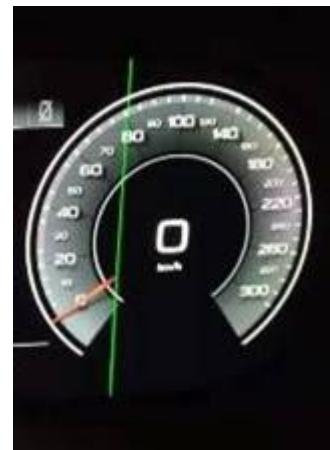
- A red, green, or blue continuous vertical line is displayed on the instrument cluster (pixel fault) (Figures 1 - 2).
- The line may be vertical or horizontal.

Figure 1. The vertical line through the instrument cluster display.

There is a hardware issue in Audi virtual cockpit.

2. Please replace the instrument cluster, J285 (address word 0017) according to the Elsa Repair Manual.

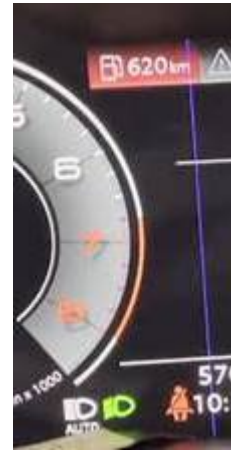
Figure 2. The vertical line through the instrument cluster display.
