Technical Service Bulletin

91 No diagnostics communication to the telematics control module

91 22 20 2056076/14 August 11, 2022. Supersedes Technical Service Bulletin Group 91 number 21-45 dated October 25, 2021, for reasons listed below.

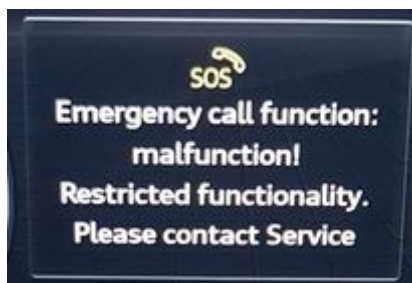
- An SOS Warning might be displayed in the instrument cluster (Figure 1).

Figure 1. Emergency call malfunction warning.

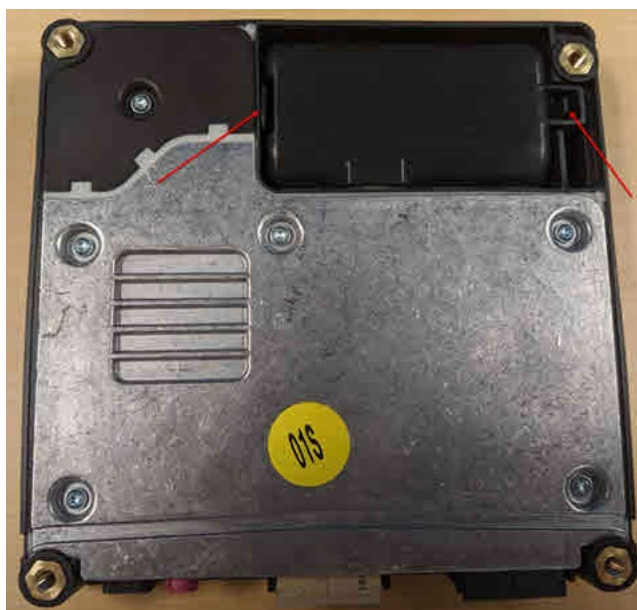
Figure 2. Backup battery compartment location.

1. Remove and unplug the telematics control module, J949 (address word 0075) according to the Elsa Repair Manual.
2. Open the battery compartment of the telematics control module, J949 (address word 0075) and disconnect the backup battery (Figures 2 - 3).

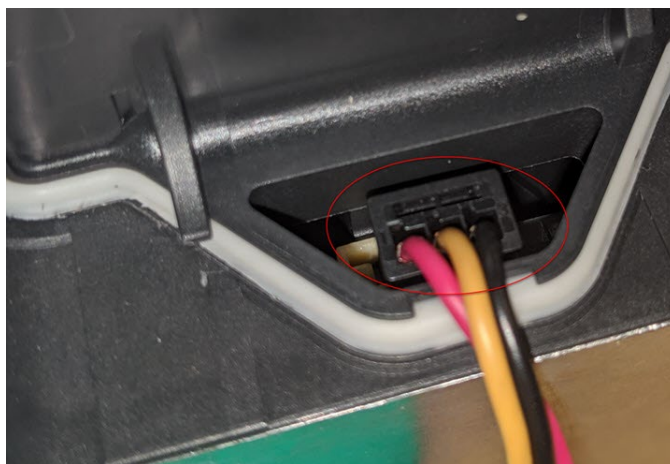
Figure 3. Backup battery connector (no release mechanism).
