Technical Service Bulletin

91 SOS Emergency call function deactivated message in the cluster, DTC U153E00 is stored in the telematics module

91 22 21 2055945/10 August 11, 2022. Supersedes Technical Service Bulletin Group 91 number 22-99 dated May 5, 2022, for reasons listed below.

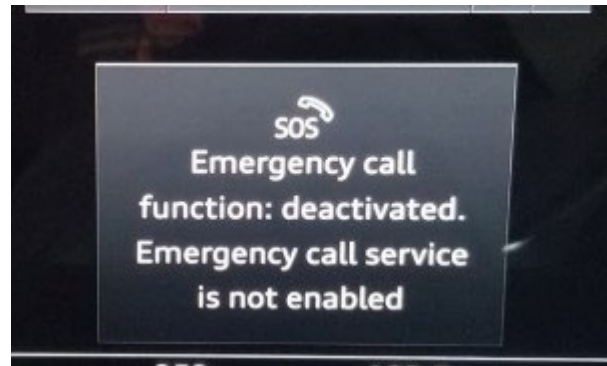
- The warning message “SOS Emergency call function deactivated” is seen in the instrument cluster (Figure 1 or 2).

Figure 1. SOS warning in the instrument cluster.

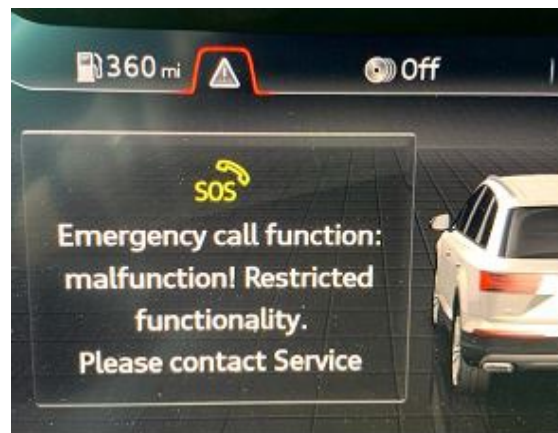
Figure 2. SOS warning in the instrument cluster.
