# Service Bulletin

Bulletin No.: 22-NA-155

**Subject:** Harsh Transmission Downshift 4-3

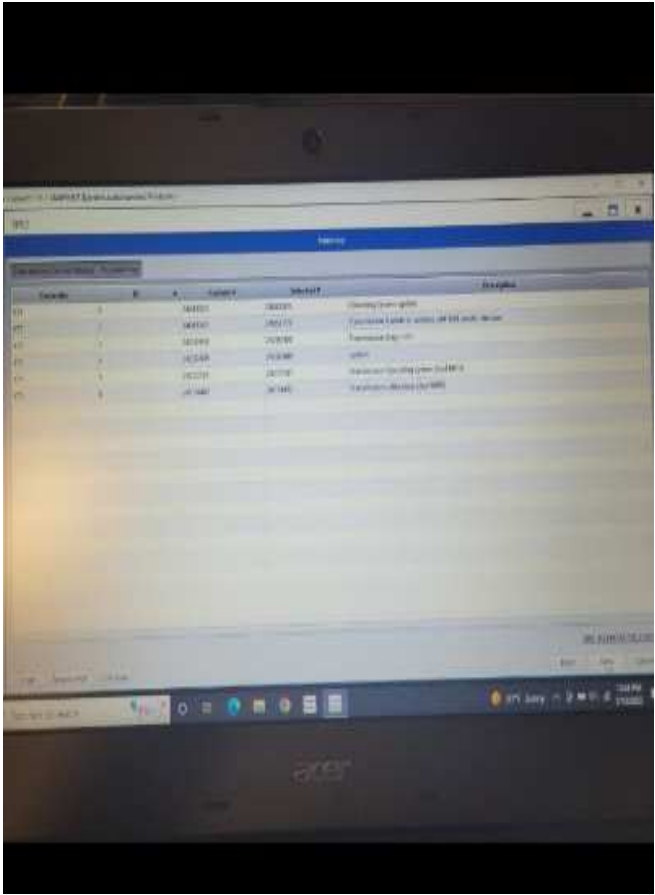
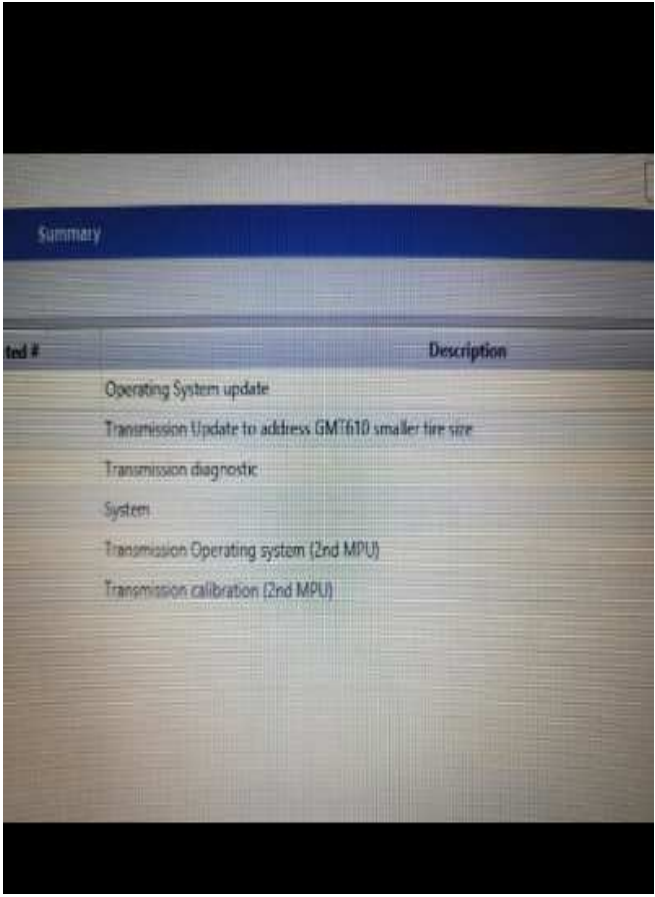
<b>Involved Region or Country</b>	United States, Canada, Mexico
<b>Additional Options (RPOs)</b>	
<b>Condition</b>	Some customers may comment on a harsh/hard transmission 4th to 3rd downshift.
<b>Cause</b>	The cause of the condition may be software anomalies in the transmission and may be elevated with customer driving habits.
<b>Correction</b>	<p>Update the TCM (Transmission Control Module) with "Transmission update to address GMT610 smaller tire size".</p>

<table><tr> <th>Updated #</th> <th>Description</th> </tr><tr> <td></td> <td>Transmission Update to address GM7610 smaller tire size</td> </tr></table>
