Service Bulletin

Bulletin No.: 22-NA-157

Subject: Transmission Control Module Update

Brand:	Model:	Model Year:		VIN:		Engine:	Transmission:
		from	to	from	to		
Chevrolet	Corvette	2021	2021	—	—	—	—

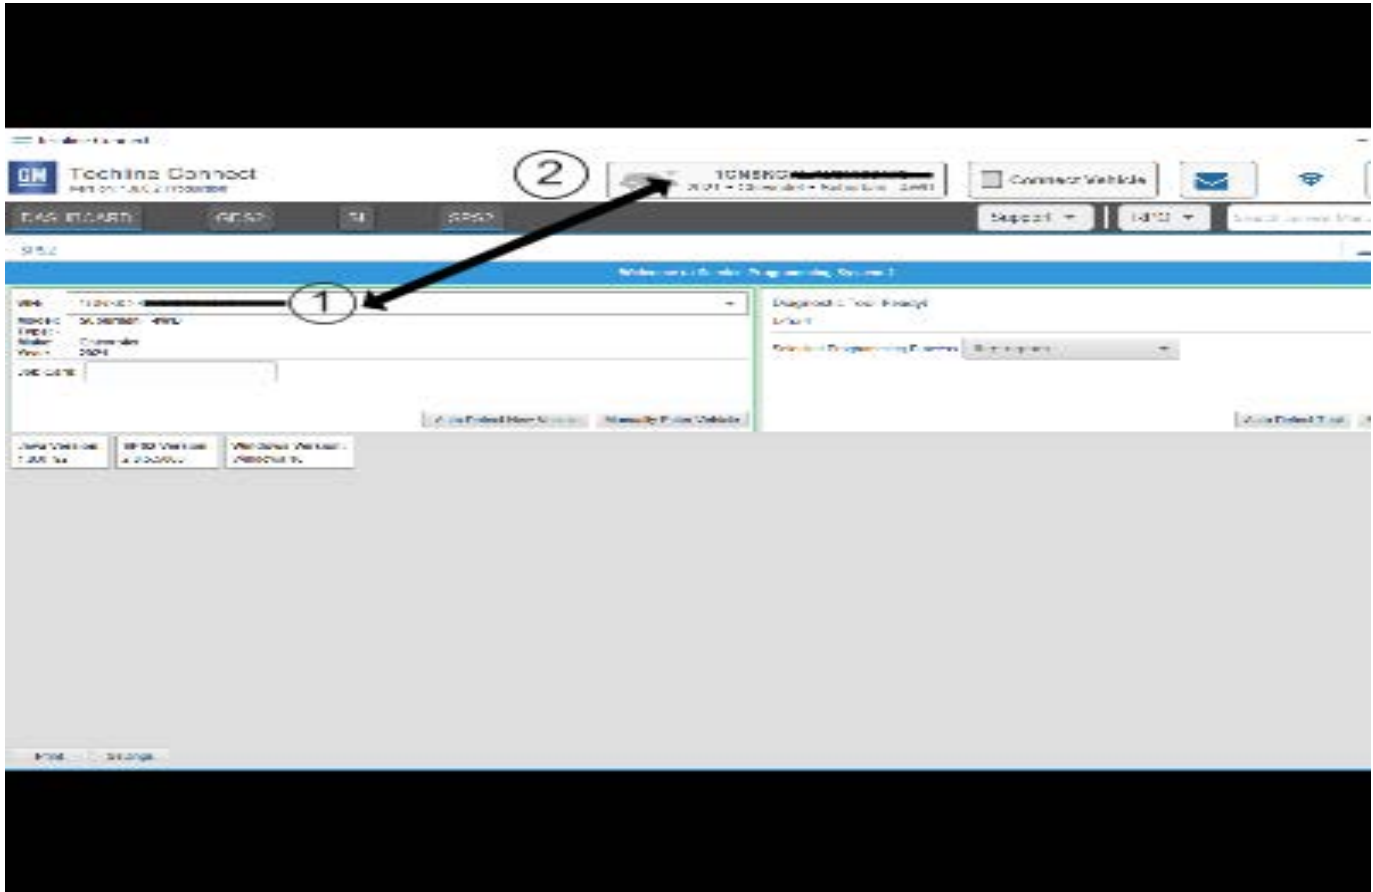
Caution: Be sure the VIN selected in the drop down menu (1) is the same as the vehicle connected (2) before beginning programming.

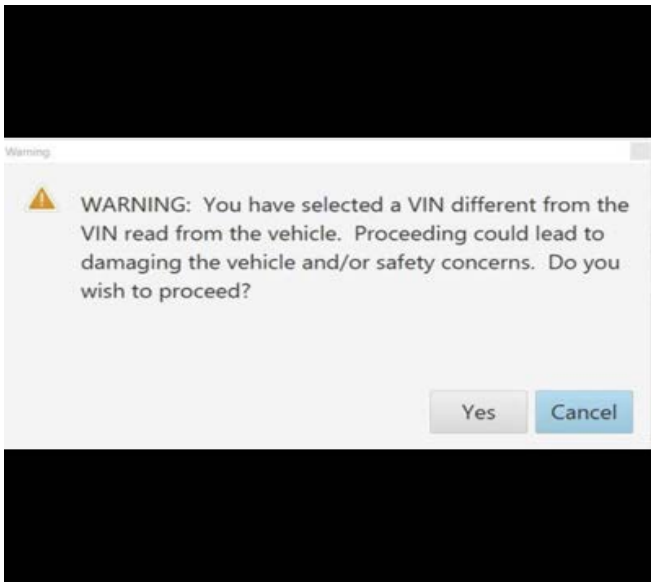
5877000

Important: If the vehicle VIN DOES NOT match, the message below will be shown.

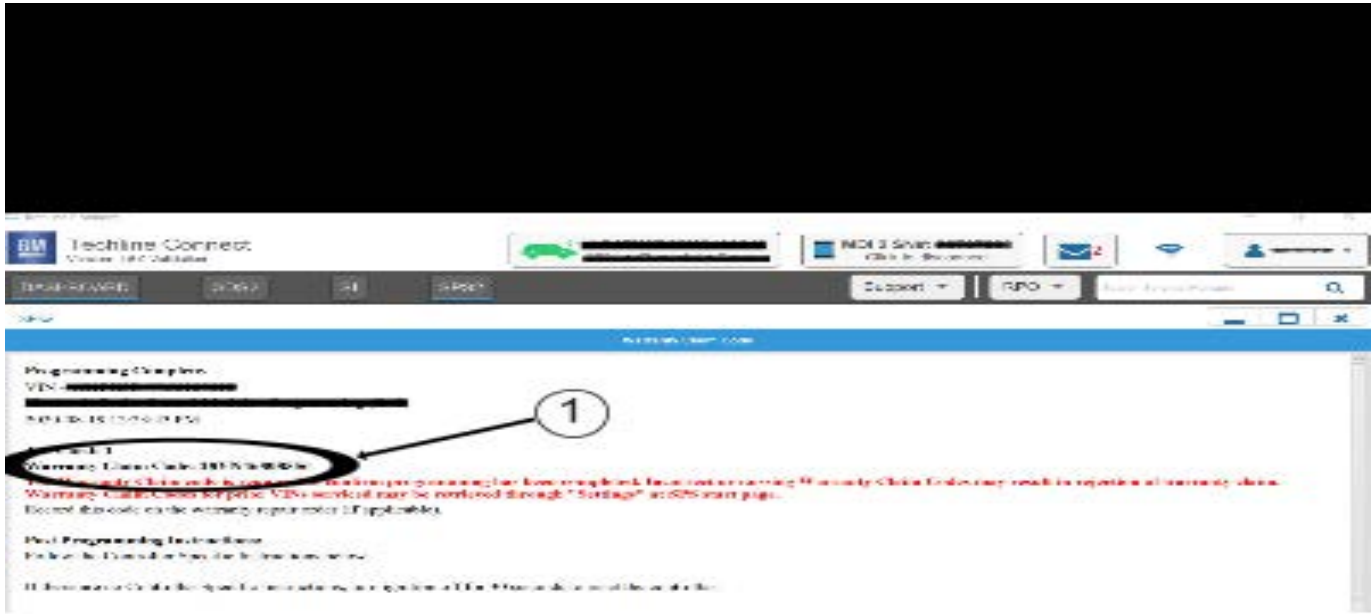
5644478

Note: The screenshot above is an example of module programming and may not be indicative of the specific module that is being programmed. Module selection and VIN information have been blacked out.

Important: To avoid warranty transaction rejections, you **MUST** record the warranty claim code provided on the Warranty Claim Code (WCC) screen shown above on the job card. Refer to callout 1 above for the location of the WCC on the screen.

1. Reprogram the Transmission Control Module.
Refer to *K71 Transmission Control Module: Programming and Setup* in the Service Manual.

2. Record the Warranty Claim Code on the job card for warranty transaction submission.

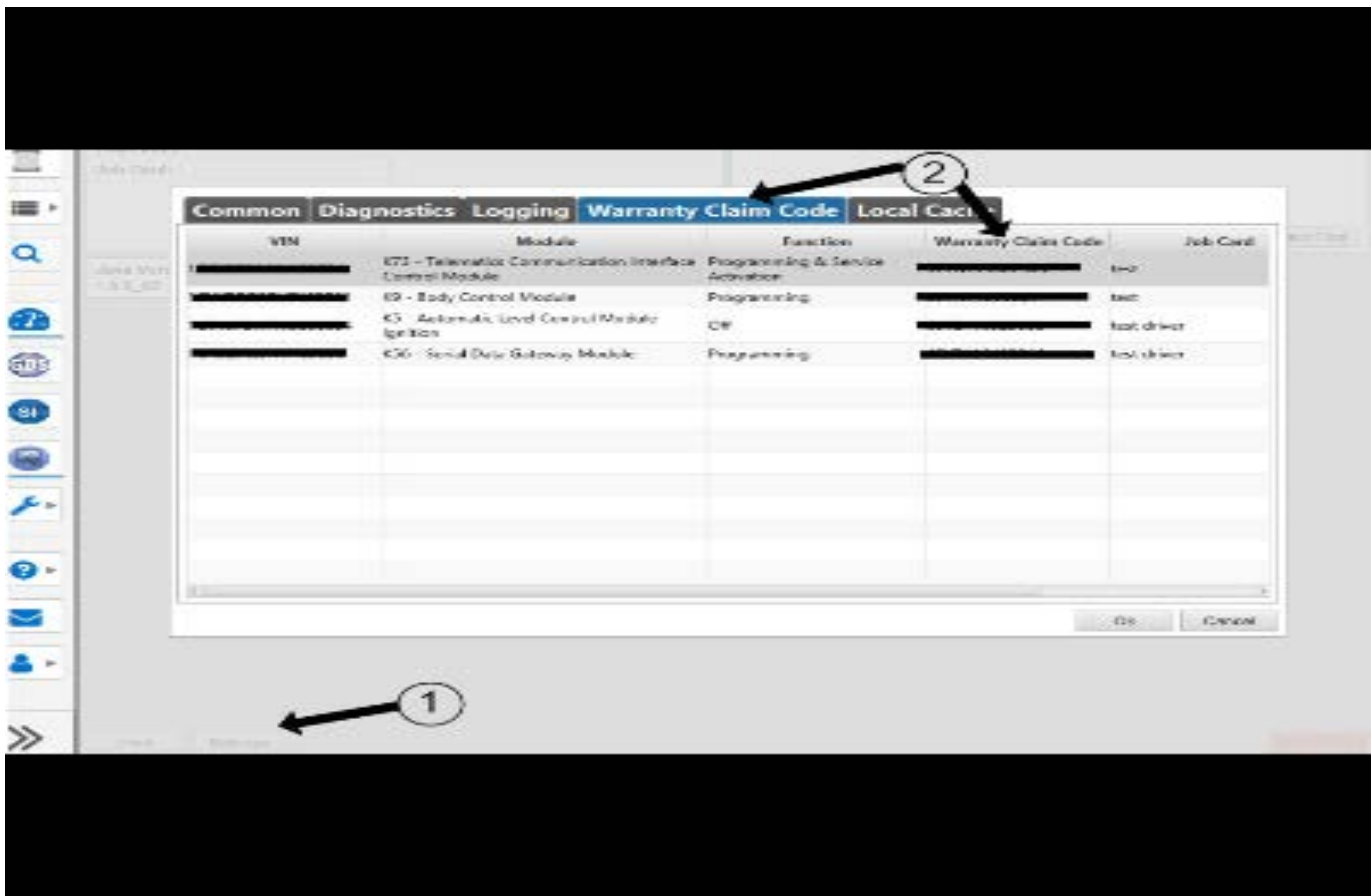
If the Warranty Claim Code was not recorded on the Job Card, the code can be retrieved in the SPS2 system as follows:

1. Open TLC on the computer used to program the vehicle.
2. Select and start SPS2.
3. Select Settings (1).
4. Select the Warranty Claim Code tab (2).
