# Customer Notification

Customer Notification: 51-1493

Mercedes Recall: 21V131

SUBJECT: **Model 907 Sprinter, Model Year 2021**  
**Torsion Bar Linkage and Mounting Hardware**

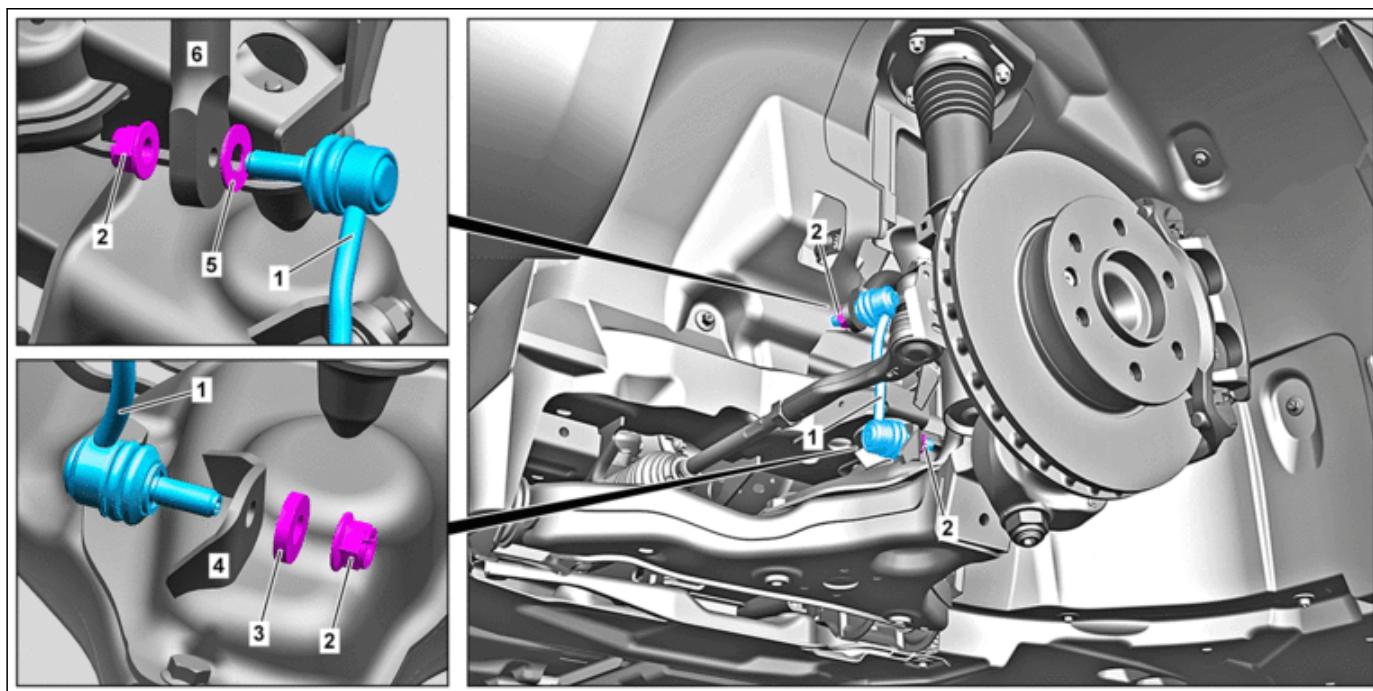
D32.35-A004-79

**Shown on model 907 with code CB4 (Stage III stabilization), left side of vehicle**

| 4 | Remove torsion bar linkages (1). | <br>Remove shims (3, 5) too.<br><b>The shim (5) may be attached to the wrong side of the torsion bar linkage (1).</b><br>Replace torsion bar linkages (1). | |

| 6 | Install new torsion bar linkages (1). | <br>Observe installation position of torsion bar linkages (1).<br>The torsion bar linkage (1) only have sufficient clearance when in the correct installation position.<br><br>Position shim (3) between lower nut (2) and stop plate holder (4), as shown.<br>Position shim (5) between threaded pin of torsion bar linkage (1) and stabilizer bar (6), as shown. | |

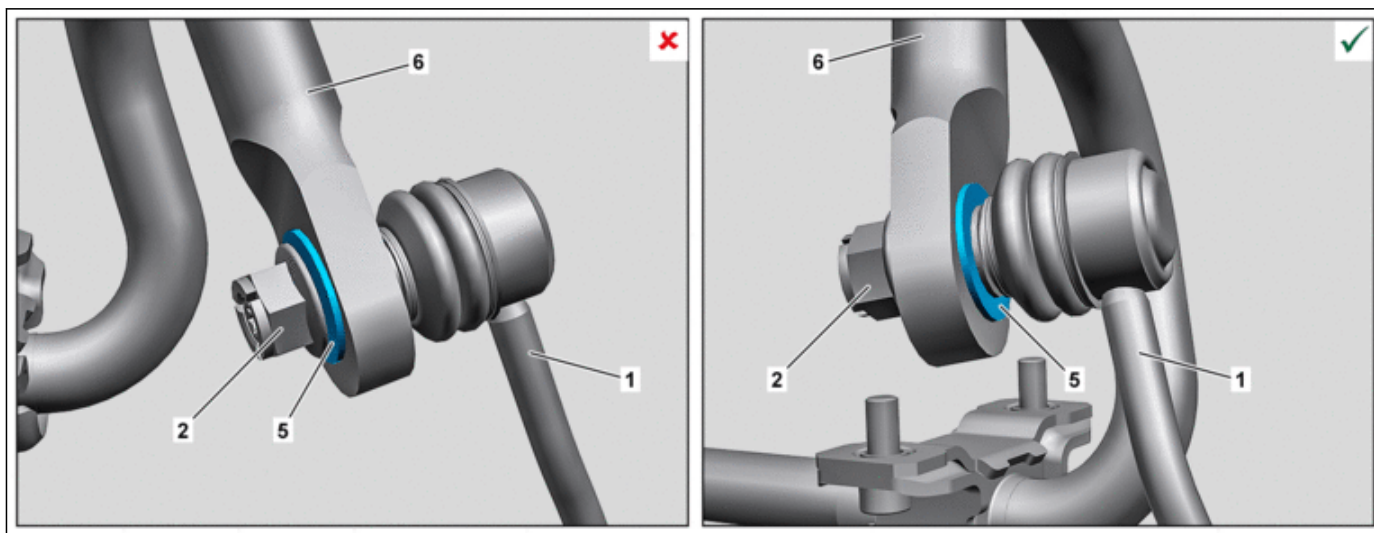
D32.35-A005-78

**Shown on model 907 with code CB4 (Stage III stabilization), left side of vehicle**

| 7 | <p>Attach nuts (2) to torsion bar linkages (1) on right and left side of vehicle.</p> <p><b>Notice</b></p> <p>Notes on self-locking nuts and bolts</p> <p>Note on calculation of tightening torque when using insertion or socket tools with various effective lengths</p> | <p> Nut, torsion bar linkage to stabilizer bar</p> <p> Nut, torsion bar linkage to transverse control arm</p> <p>If the threaded pin on the ball head turns too,</p> <p style="text-align: center;">↓</p> <p>counterhold the threaded pin.</p> | <p>AH00.00-P-0001-01KOA</p> <p>AH00.00-P-0015-01CW</p> <p><a href="#">BA32.35-Z-1002-02KTS</a></p> <p><a href="#">BA32.35-Z-1003-02KTS</a></p> |
