MAS003154 (MSC 22-30)

Campaign 515

## Service Campaign 515 Levante M161 MY22 – Internal Tail Lamp Check

DATE: JULY 8 2022

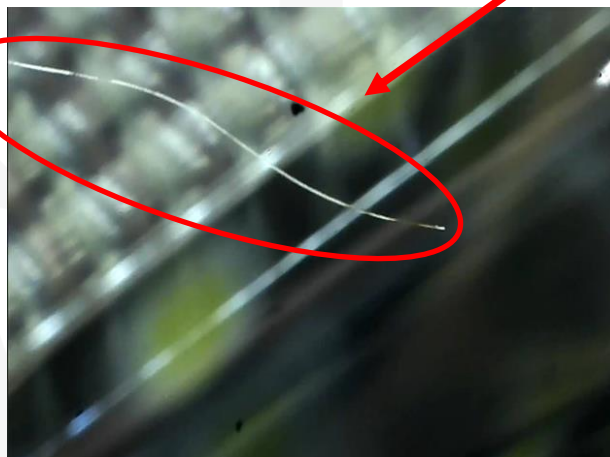
PICTURE 1

1. Always check in ModisCS+ to see if the vehicle is involved in this campaign and if the campaign has not been previously performed.
2. Open and close the rear trunk lid door (tailgate) 10 times using the power trunk button.  
**Caution:** Do not force the tailgate open or close by hand. Doing so may damage the tailgate motors.
3. With a low-pressure water spray imitating medium to heavy rainfall, spray the LH and RH internal tail lamps 90 secs each. (a total of 3 minutes for both) **Caution:** Make sure the rear trunk lid door (tailgate) is fully closed. Do not use a high-pressure water jet.
4. Heat each rear internal lamp for 2 minutes with a common/domestic hair dryer (1500-1800W) at a distance of 30-40 cm.
5. Check for the presence of fog, moisture, water infiltration, and/or cracks. SEE PIC 1

6. If water infiltration/fog/moisture and/or cracks are not present, the internal tail lamp can be considered **OK**. ► The operation is completed. No further action required.

7. If water infiltration/fog/moisture and/or cracks are present, the internal taillight must be considered as **NOT OK** and must be replaced. ► Replace only the defective tail light following one of the procedures below:

- **8.31.003.0 INSIDE RH. TAILLIGHT – Removal/refitting or replacement**
  - **8.31.004.0 INSIDE LH. TAILLIGHT – Removal/refitting or replacement**
8. Inspect the external taillight as well following the conditions below:
