**Campaign 518**

# Service Campaign 518

## MC20 – New air intake shield at rear bumper

DATE: JULY 29 2022

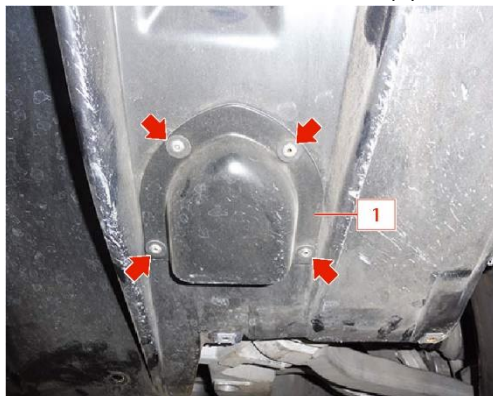
2. Drive the vehicle on the lift and safely raise the vehicle in the air.
3. With a suitable tool remove the rivets and the RH air intake shield (1).

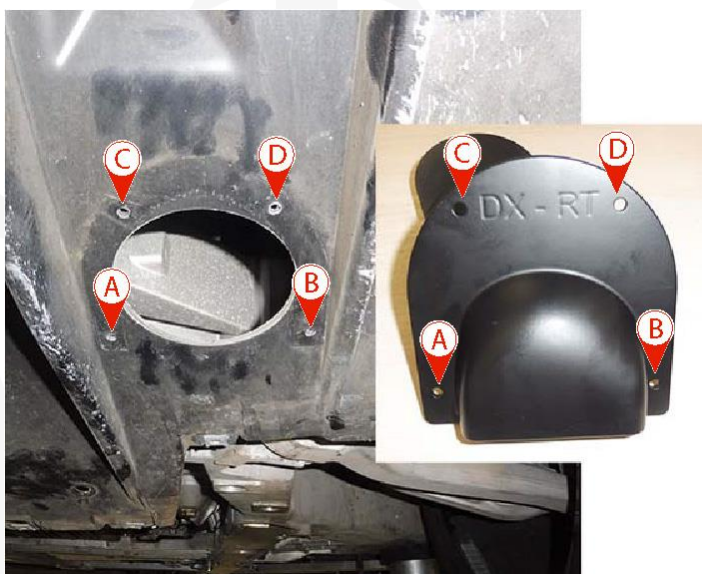
4. With the old intake shield removed. Test fit the new intake shield and make sure ALL 4 rivet holes line up with the holes on the rear bumper.

- If the holes perfectly match as shown in the picture ► proceed with the "**Refitting**".
- If the holes do not match ► follow the "**Special Procedure**" indicated on the following page.
